Excavation and Additional Studies at the Haynie Site (5MT1905) by the Crow Canyon Archaeological Center Annual Progress Report 2024

R. David Satterwhite, Susan C. Ryan, Steve Copeland, Reuven Sinensky
Jamie Merewether, and Kate Hughes

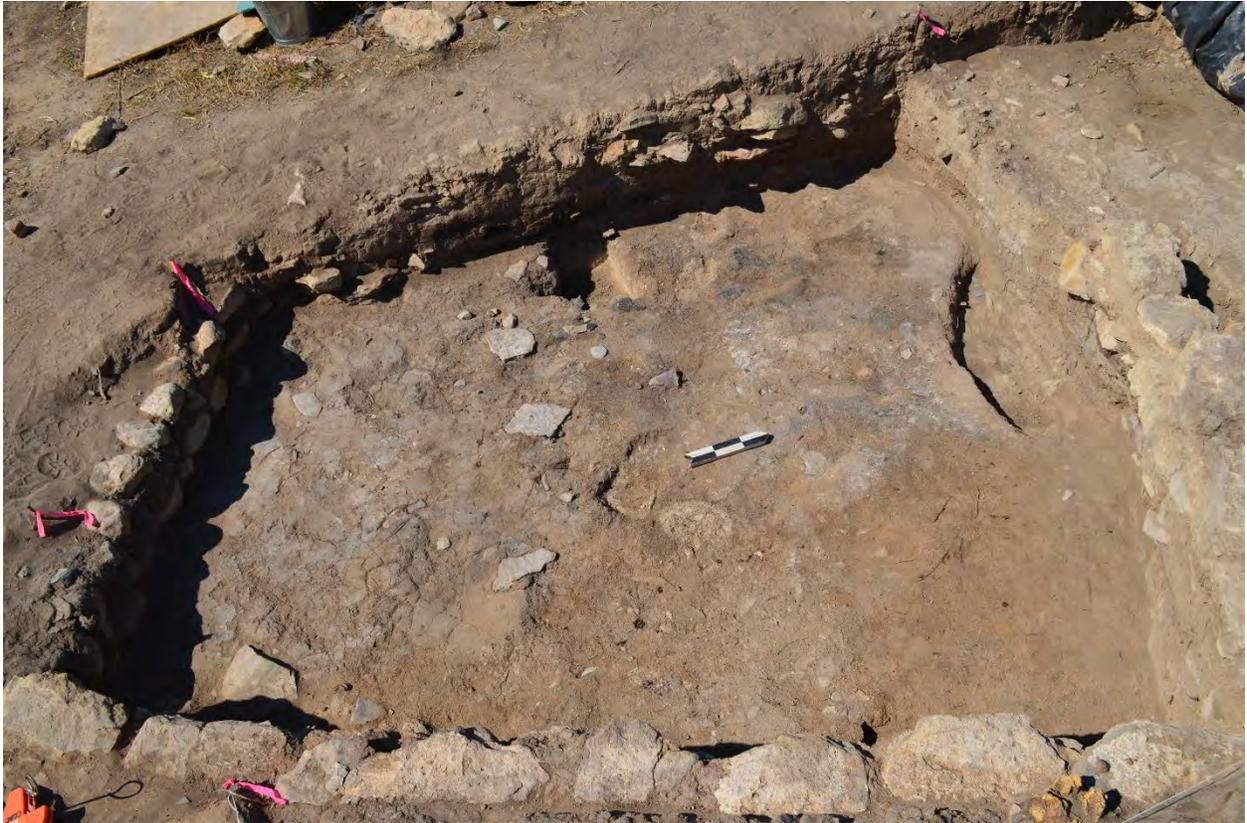
Figure 6. Structure 1042/1026, Surface 1, Haynie site. Note yellowish dung mat in northeast corner of the unit, and the white-gray excrement staining in the northwest quadrant.

As noted above, Structure 1042 contained multiple features. Features 4, 5, 6, 7, were designated Postholes (POS). All four were excavated with all available sediment collected for additional analyses. Feature 1, a Burned Spot (BSP). Features 2 and 9 were designated Pit: Not Further Specified. Feature 3 is mounded turkey dung (Other feature; OTH) with distinct coloration of surrounding sediments (Munsell 5YR 7/2, Pinkish grey). Feature 8, a Wall Other (WOT), is comprised of the melted remains of an adobe wall. Features 6, 8 and 9 are Postholes associated with Feature 3 and appear to be part of the penning barrier (Figures 6 and 7).

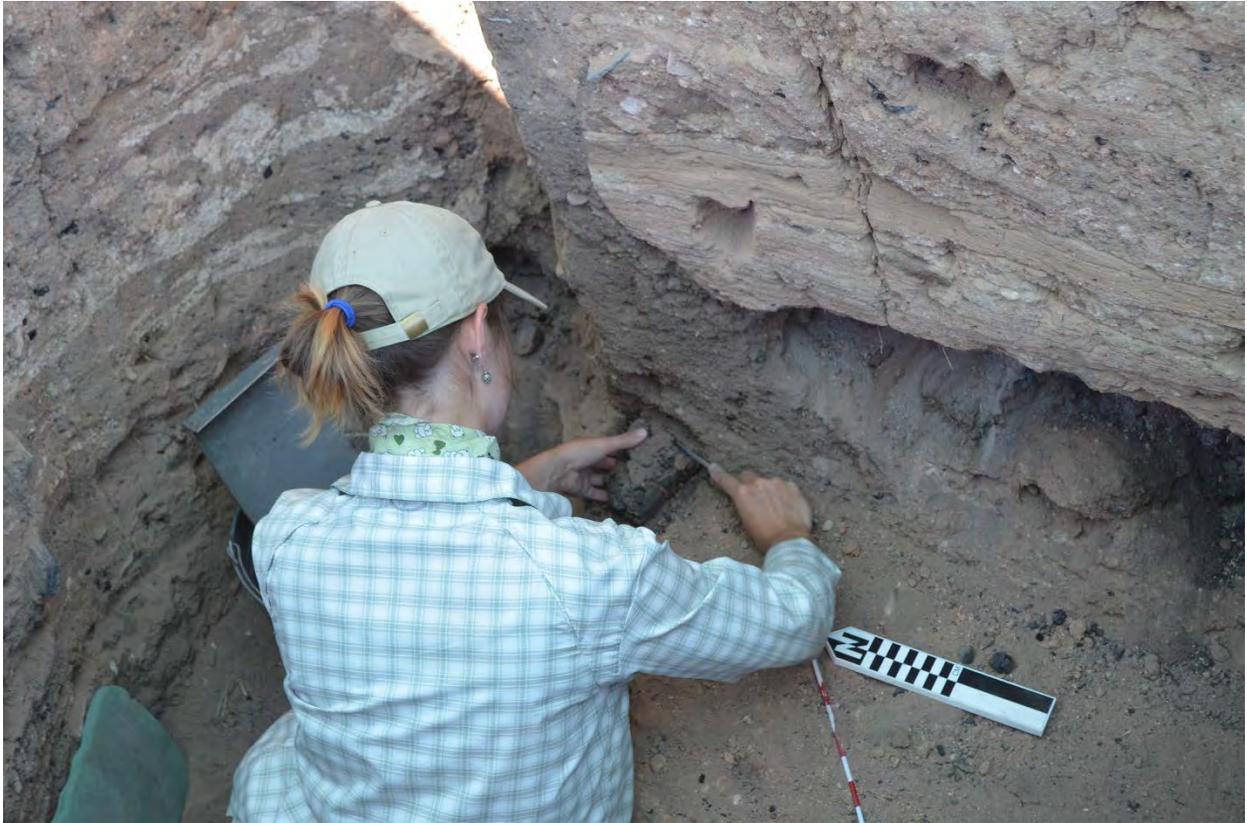
Figure 9. Structure 1115, Haynie site. Julia Frost, field intern, collects a dendrochronology sample from above Surface 1.

In 2023, testing focused on removing the redeposited fill from the 2000s backhoe trench (Structure 1115). Crow Canyon's College Field School students conducted this work and re-exposed Surface 1. Within the southeast profile wall of the trench, intact burned roof beams were visible in the profile. In 2024, a 1-x-1-m unit was established adjacent and south of the trench (448.5N 425E) to attain possible datable roofing material for this structure. Multiple largely intact wood samples were collected. These samples were burned and rested immediately above, or directly on, Surface 1. In addition to dendrochronology samples, pollen, sediment, and vegetal roofing material, or closing material, samples were collected. These samples are pending analyses, and the dendrochronology samples will be sent to the Laboratory of Tree-Ring Research in Tucson, Arizona for dating in the winter of 2025.

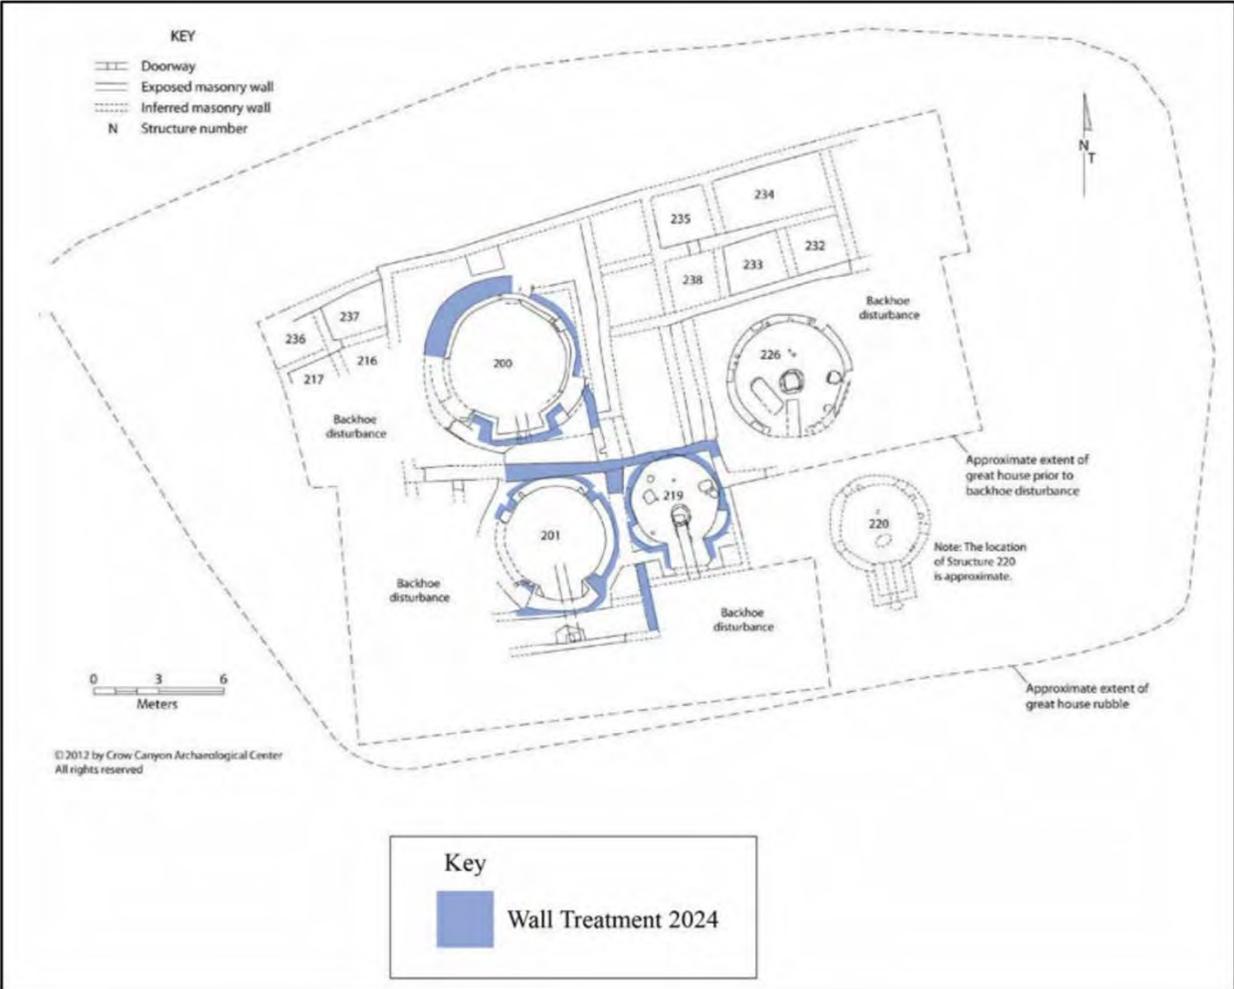
Figure 10. Plan map highlighting 2024 wall treatments at the Haynie site east great house (Diederichs 2024, based on Ryan 2013:663).

In 2024 The Archaeological Conservancy contracted Woods Canyon Archaeological Consultants to conduct stabilization of Structures 200, 201, and 219 (all kivas) and Structure 210 (masonry room) (Figure 10) in the east great house (Diederichs 2024). This work was completed in April 2024. The treatment primarily involved recapping walls and repointing the upper three-to-five courses of masonry (see Appendix D). The standing masonry walls were stabilized to mitigate threatening conditions of unstable and loose stones in structure walls over eight feet in height (Diederichs 2024). For details of methodology, theoretical approach, and detailed descriptions of location of actual stabilized areas in each kiva or room please refer to Diederichs (2024) in Appendix D.

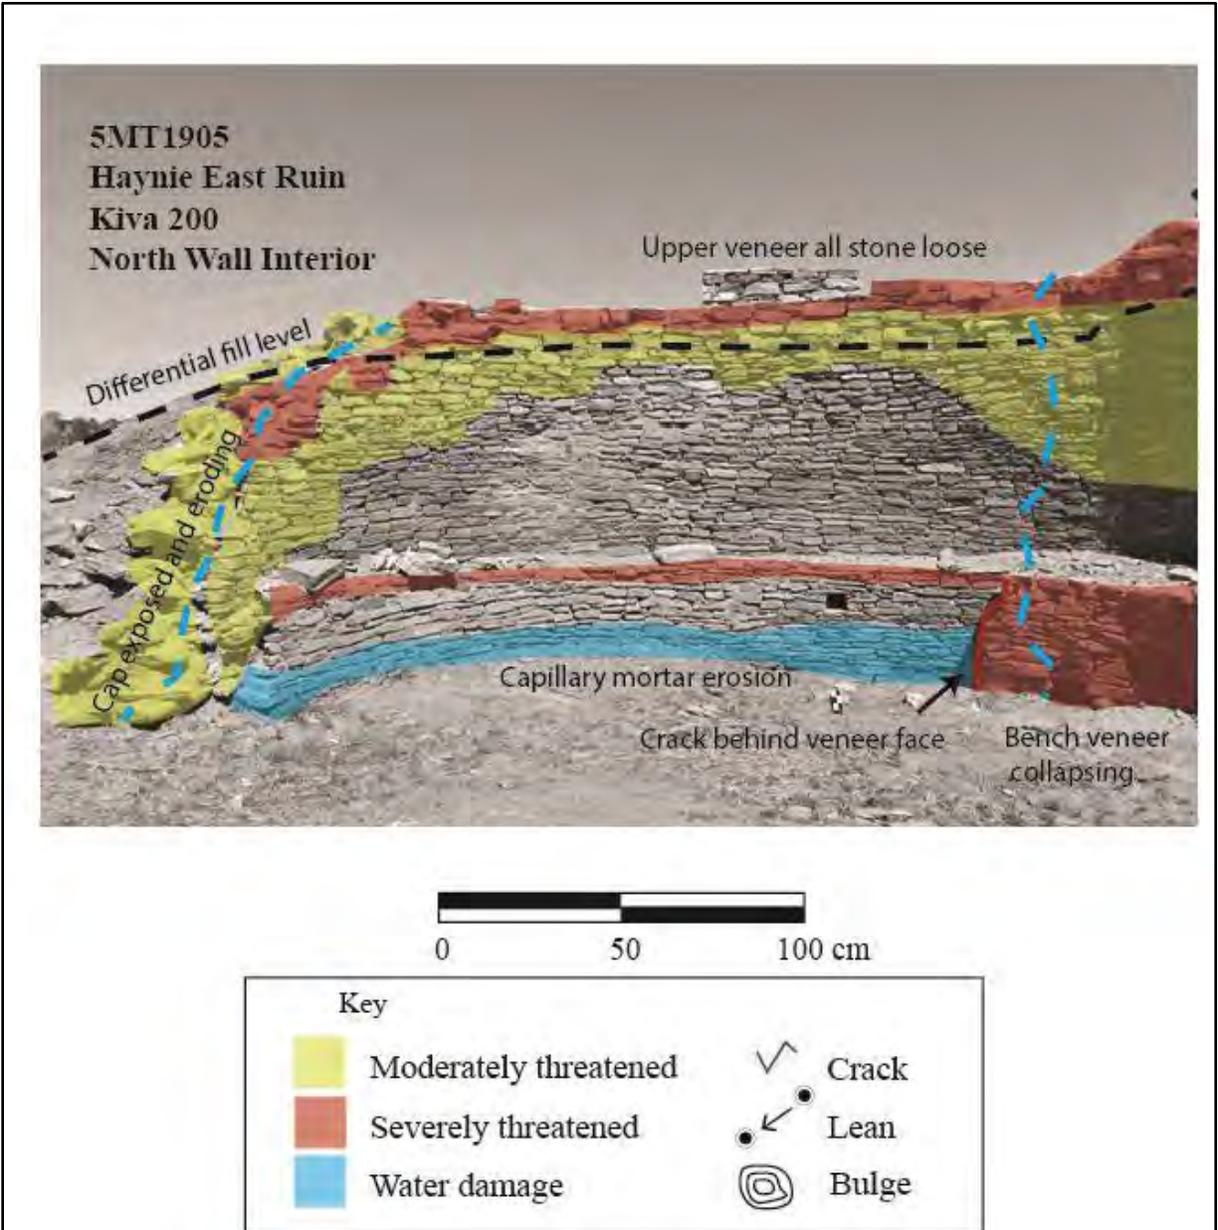
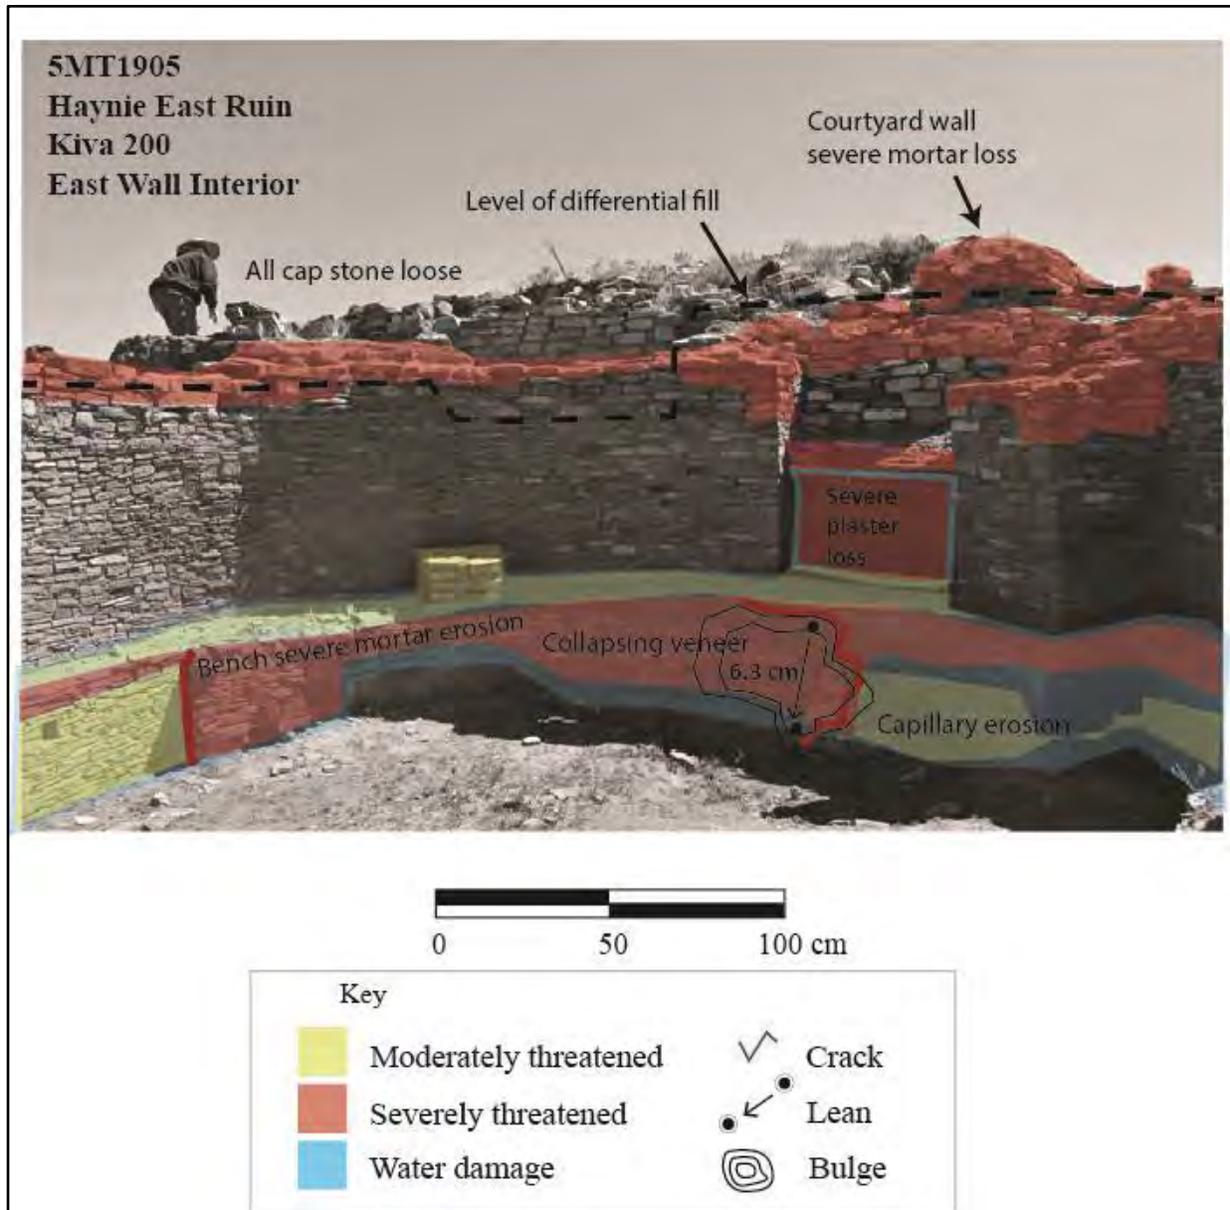
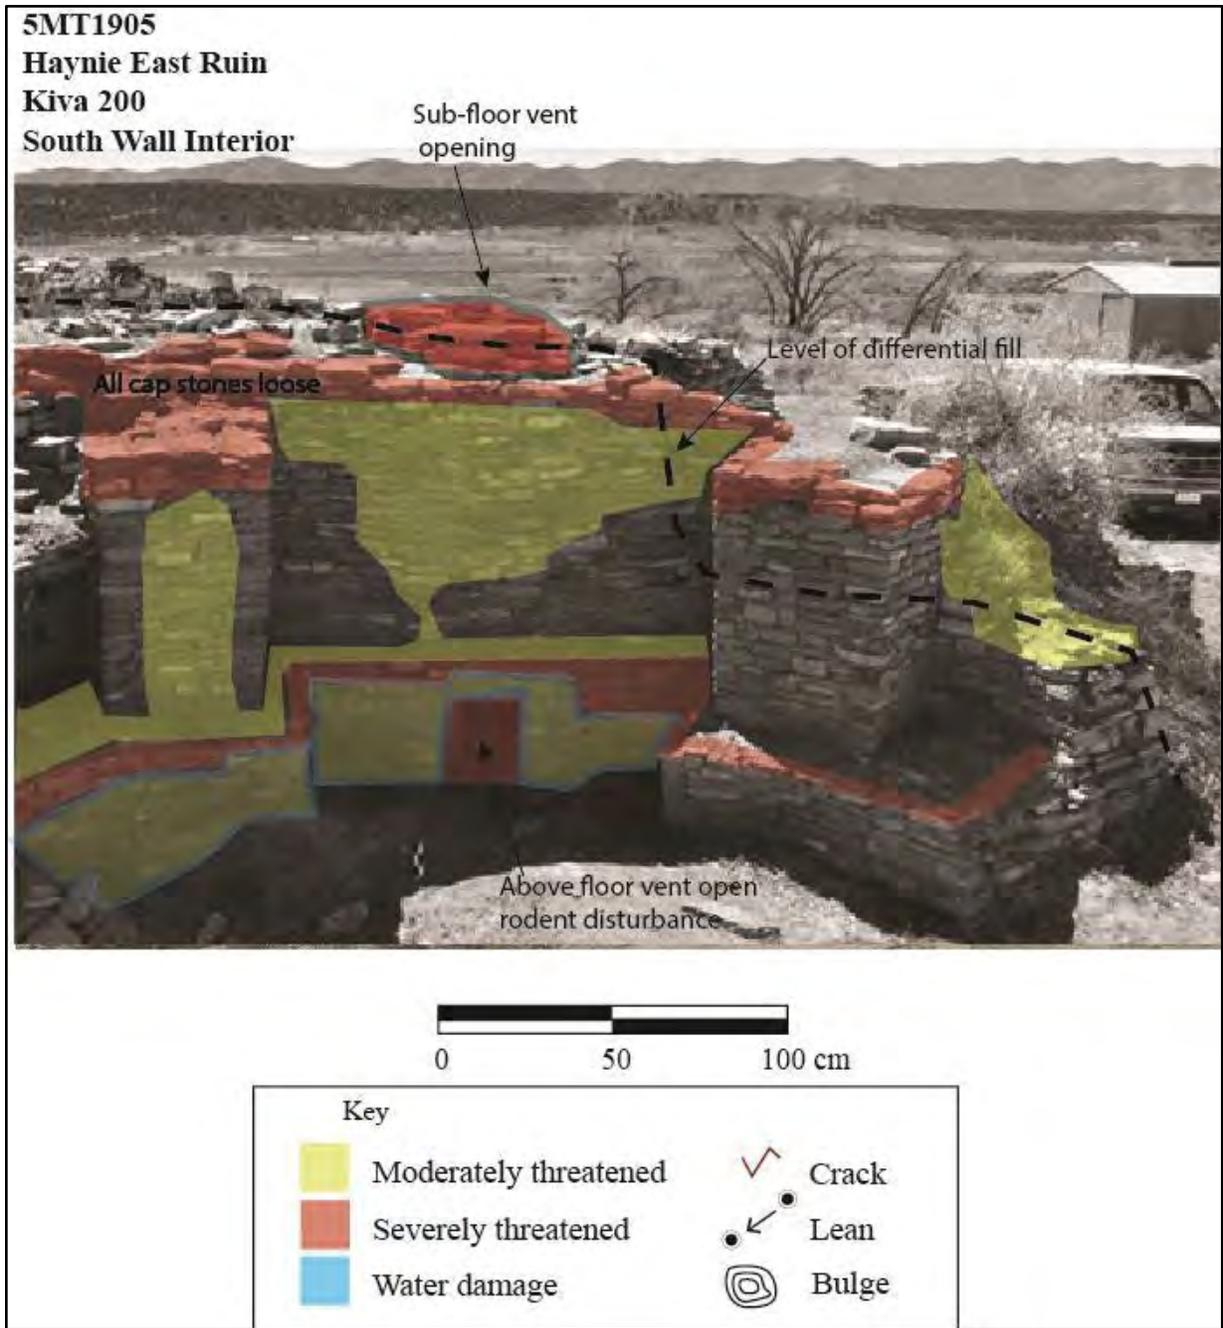
Structure 200, an above-ground, masonry kiva, is located in the northwestern portion of the great house. The north, east, south, and west walls were stabilized with wall caps and repointing where necessary. Additionally, the southern recess and southwest and southeast pilasters required stones to be reset and the addition of cap stones. Diederichs concluded that Structure 200 is structurally unstable and should be considered a high priority for additional treatment in the next two-to-five years. High priority treatments recommended include architectural documentation, plaster conservation, veneer and feature reconstruction and repointing, and/or mitigation through backfilling (Diederichs 2024).

Figure 6. Kiva 200 north interior lining wall condition issues annotated in 2017.

Figure 7. Kiva 200 east interior lining wall condition issues annotated in 2017.

Figure 8. Kiva 200 south interior lining wall condition issues annotated in 2017.

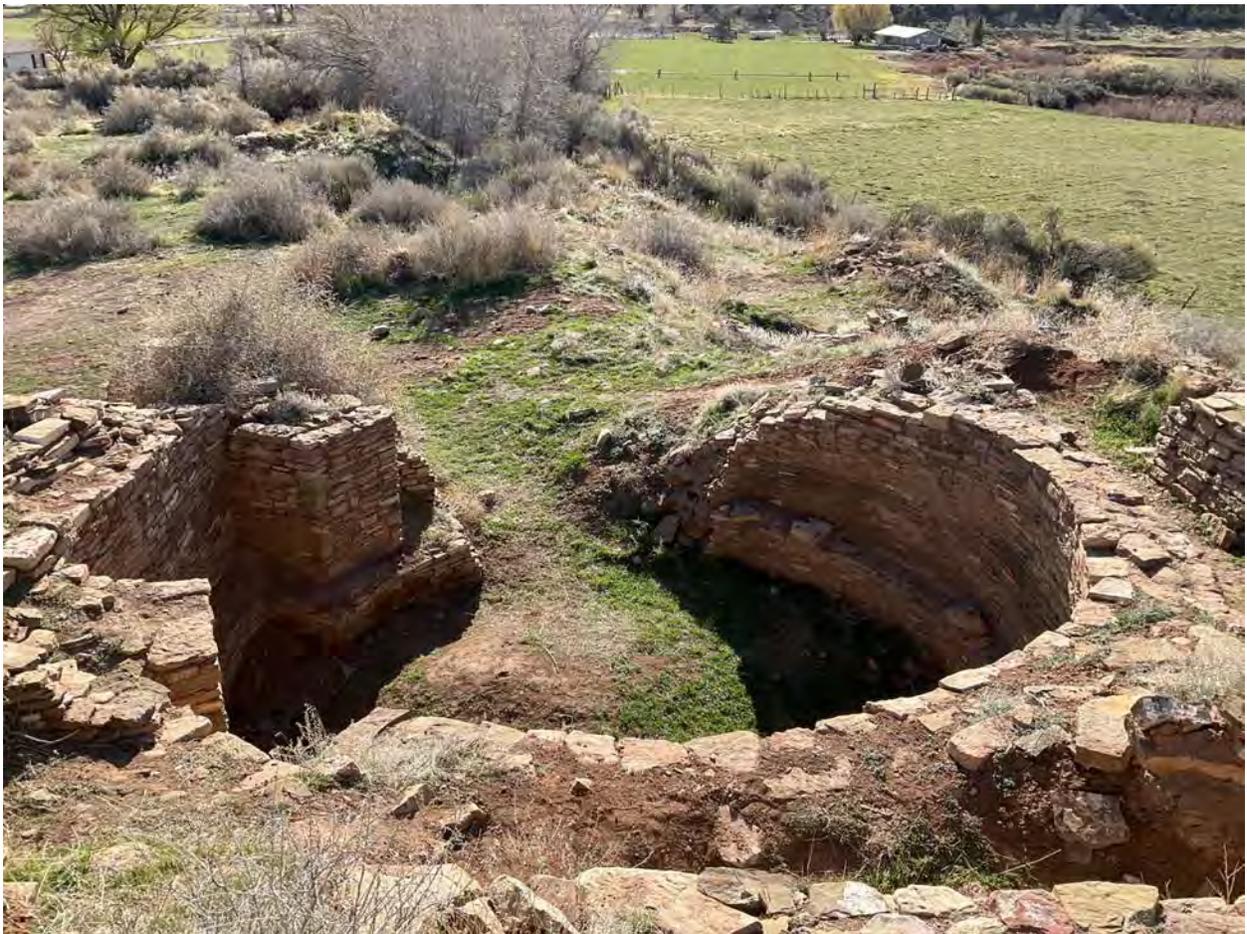
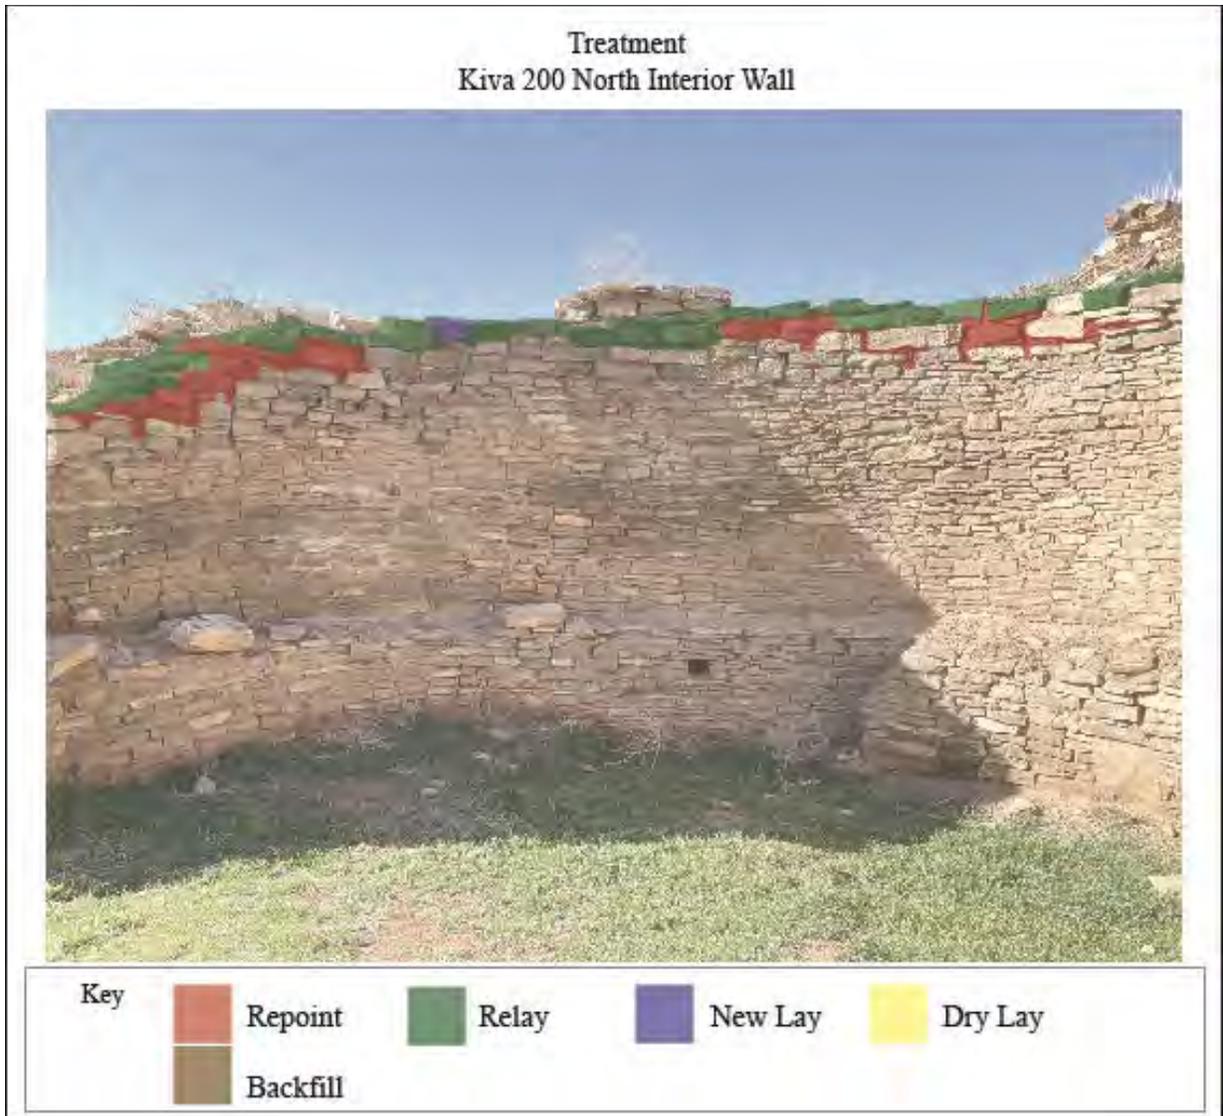
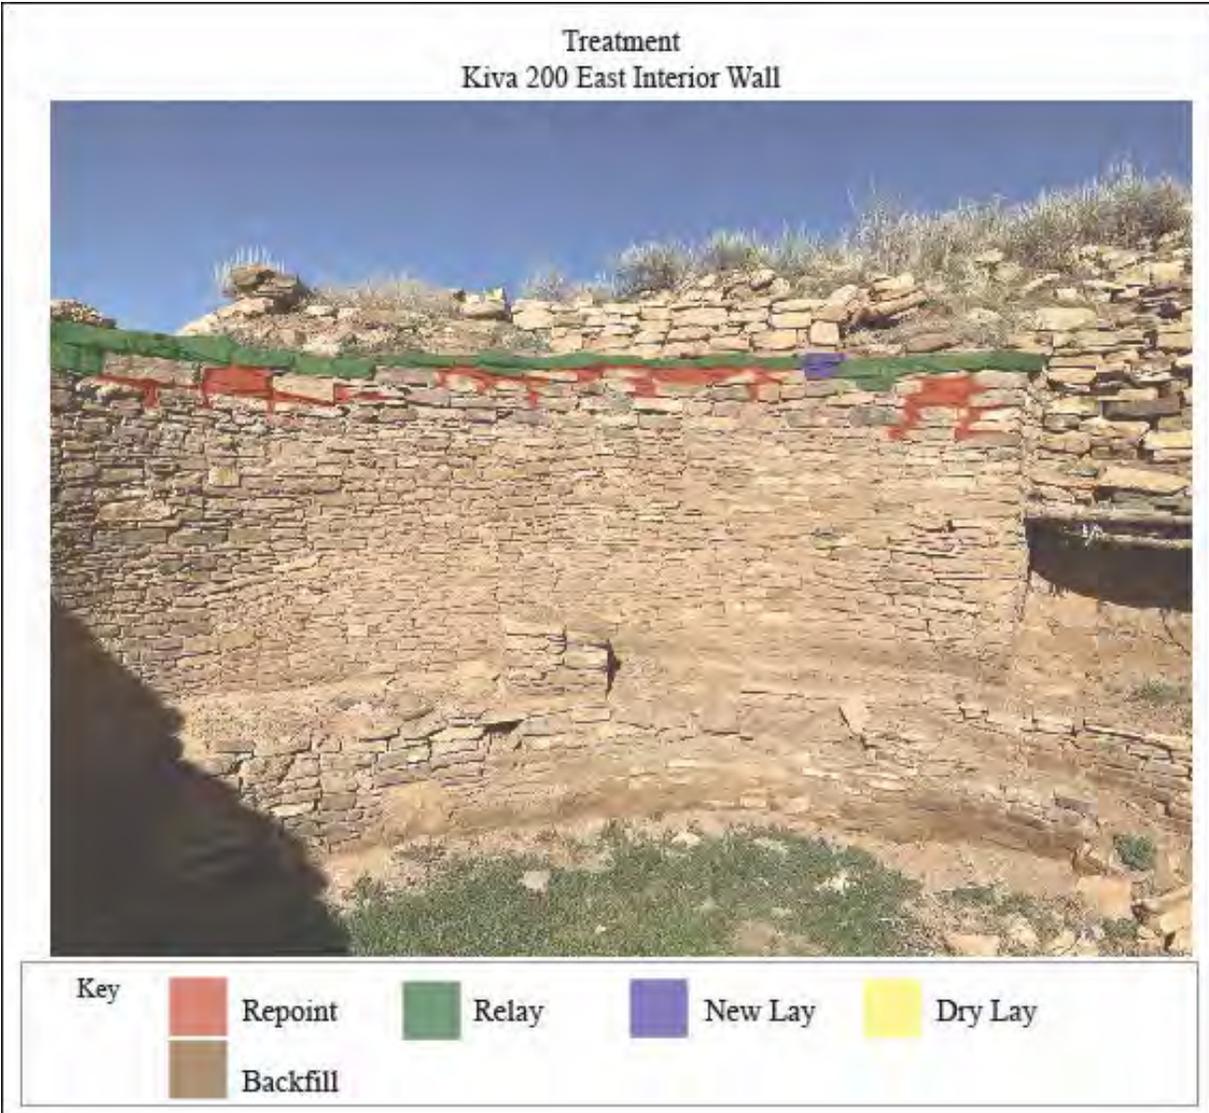
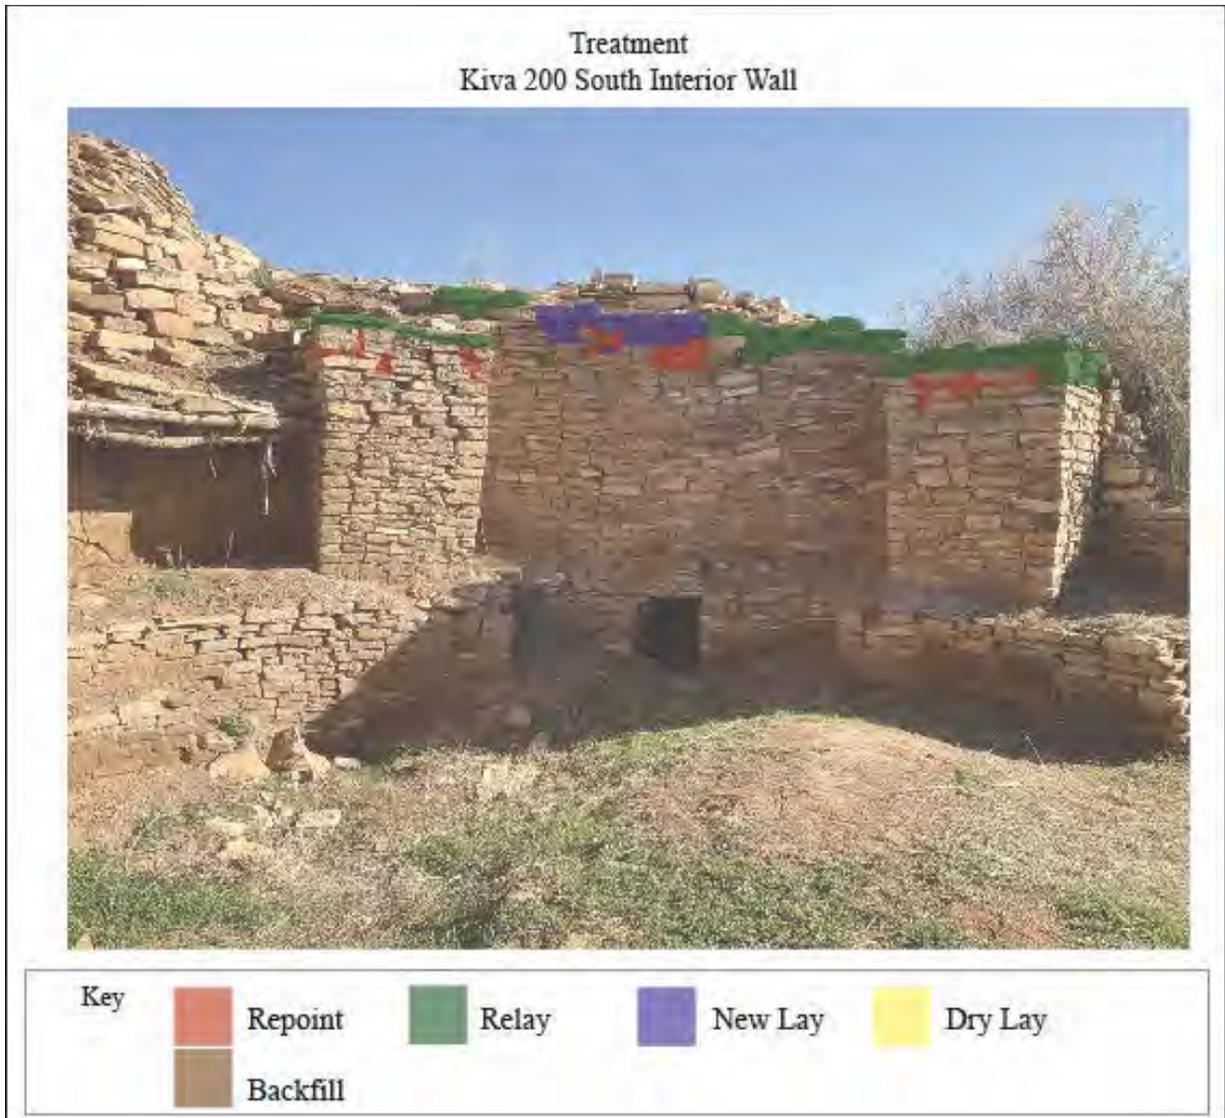
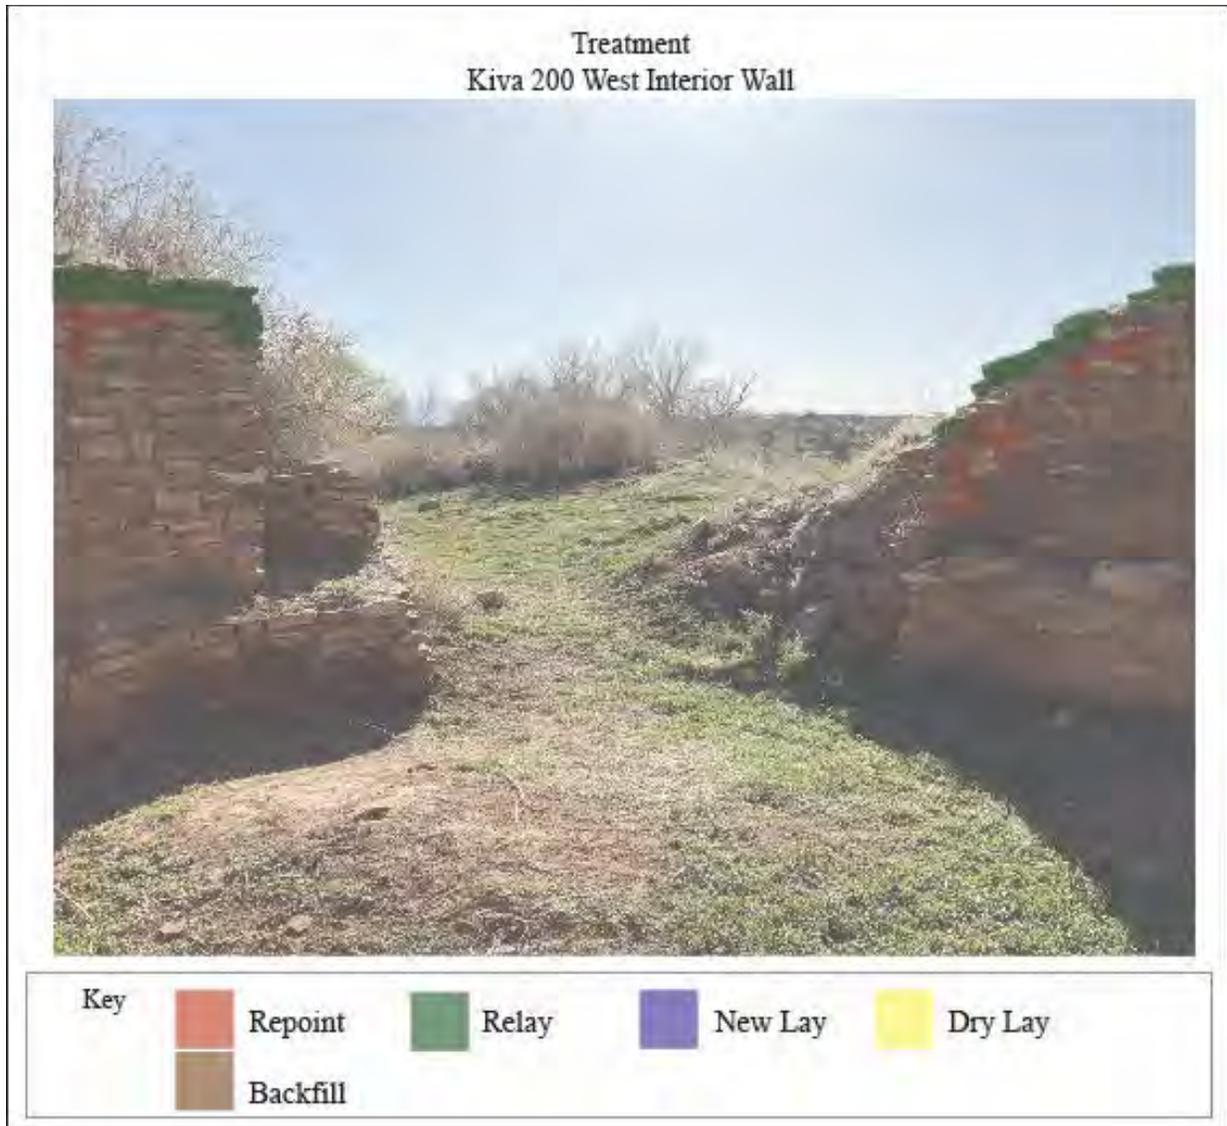
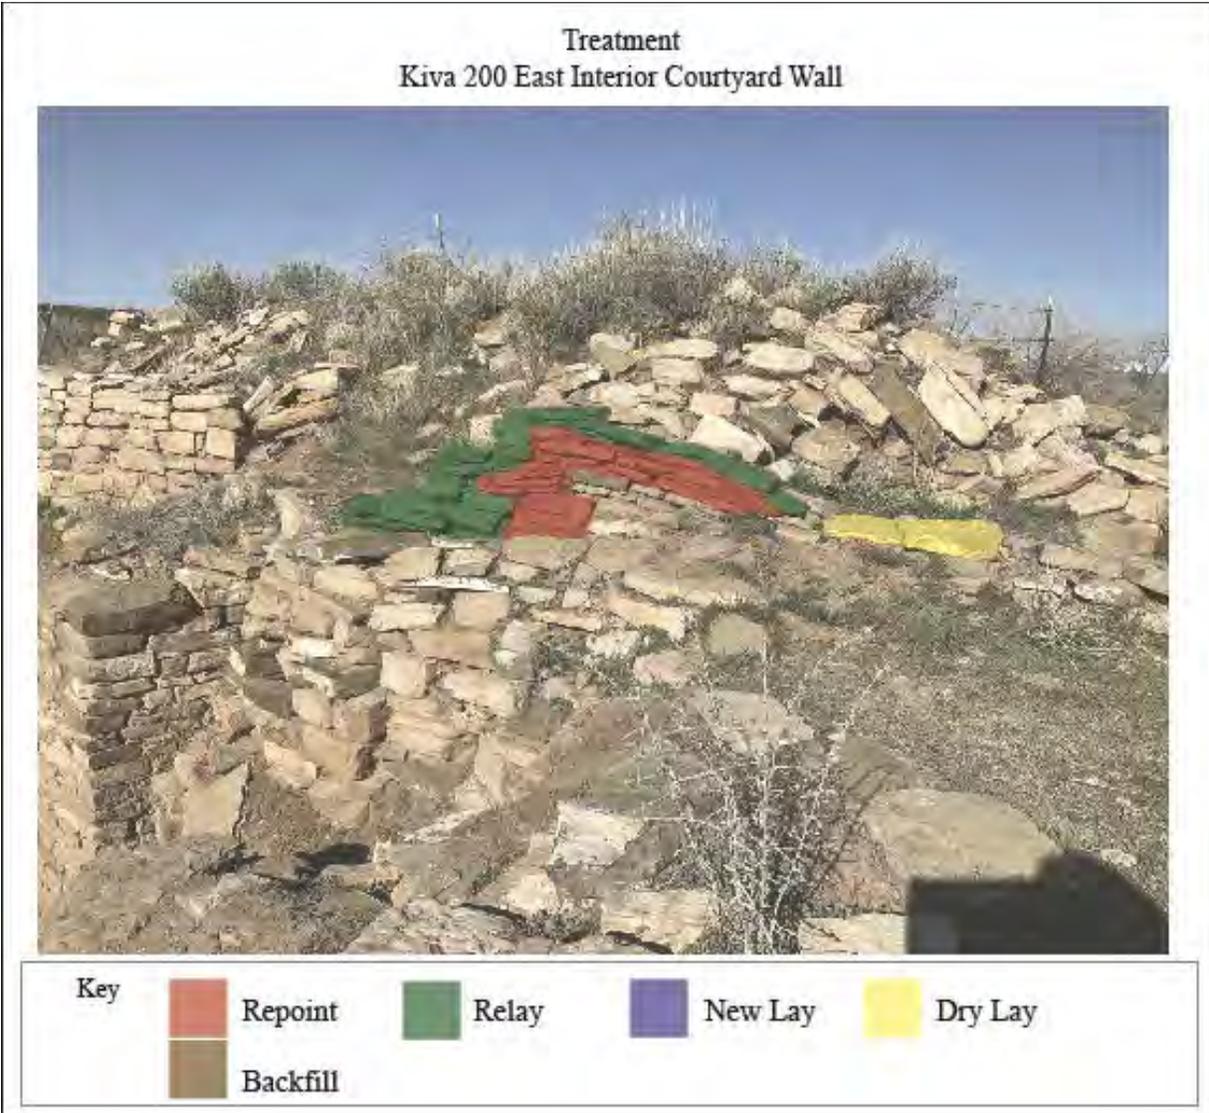
Figure 9. Overview of Kiva 200 from above after stabilization. View to the northwest.

Figure 10. Kiva 200 north interior lining wall after stabilization, annotated with conservation treatments.

Figure 11. Kiva 200 east interior lining wall after stabilization, annotated with conservation treatments.

Figure 12. Kiva 200 south interior lining wall after stabilization, annotated with conservation treatments.

Figure 13. Kiva 200 west interior lining wall after stabilization, annotated with conservation treatments.

Figure 14. Kiva 200 east wall of second story courtyard after stabilization, annotated with conservation treatments.

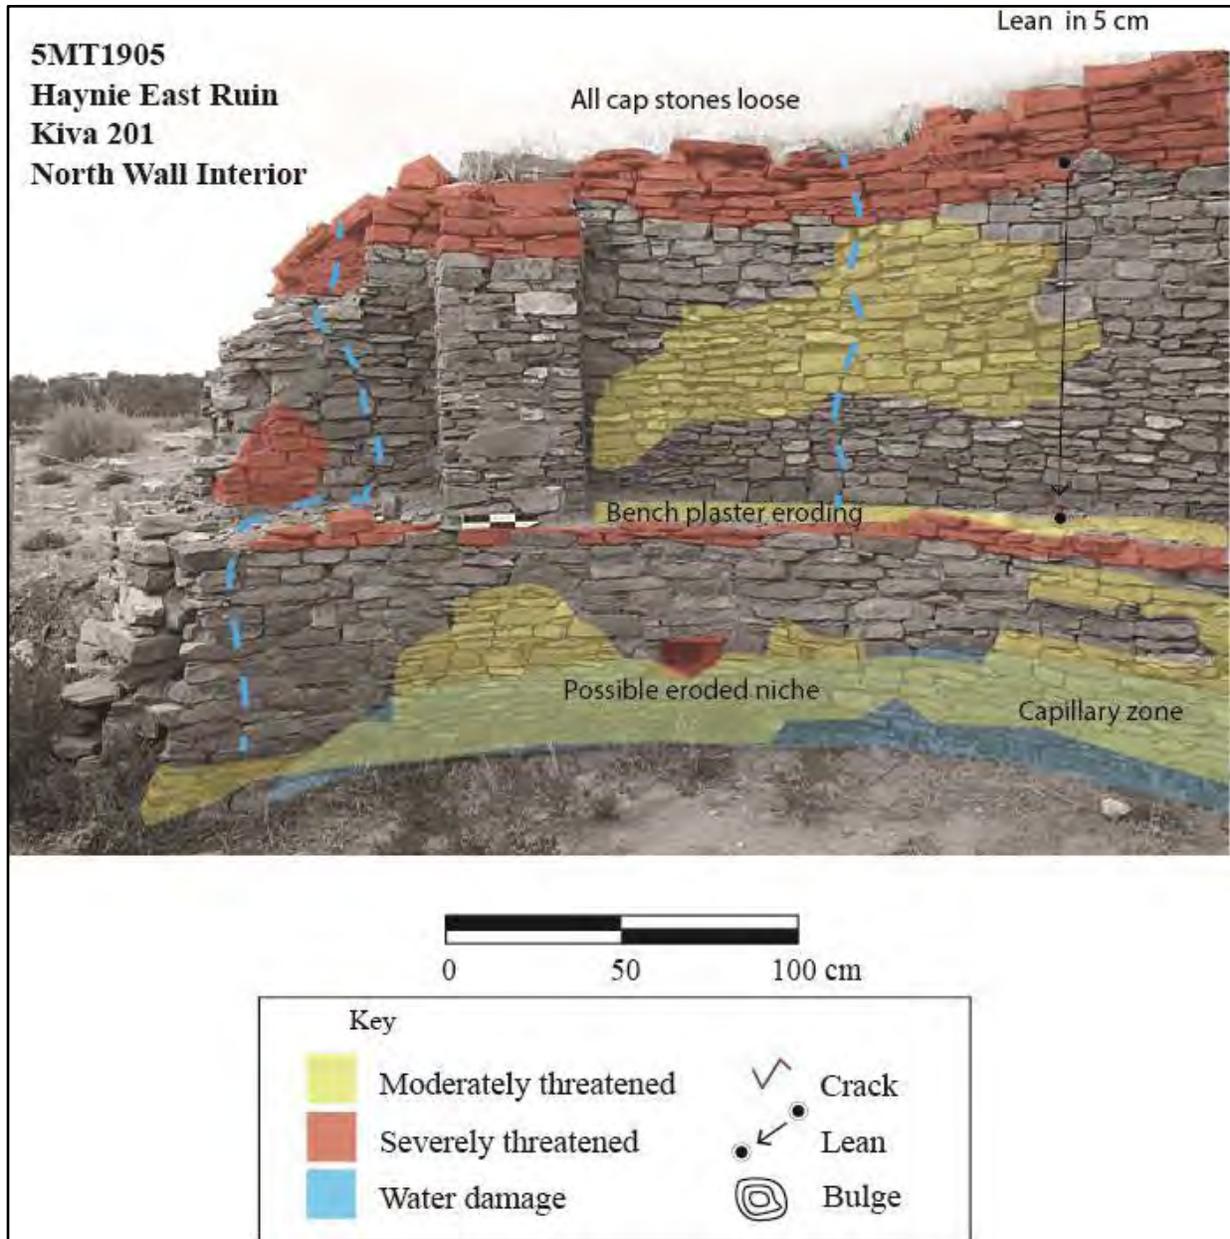
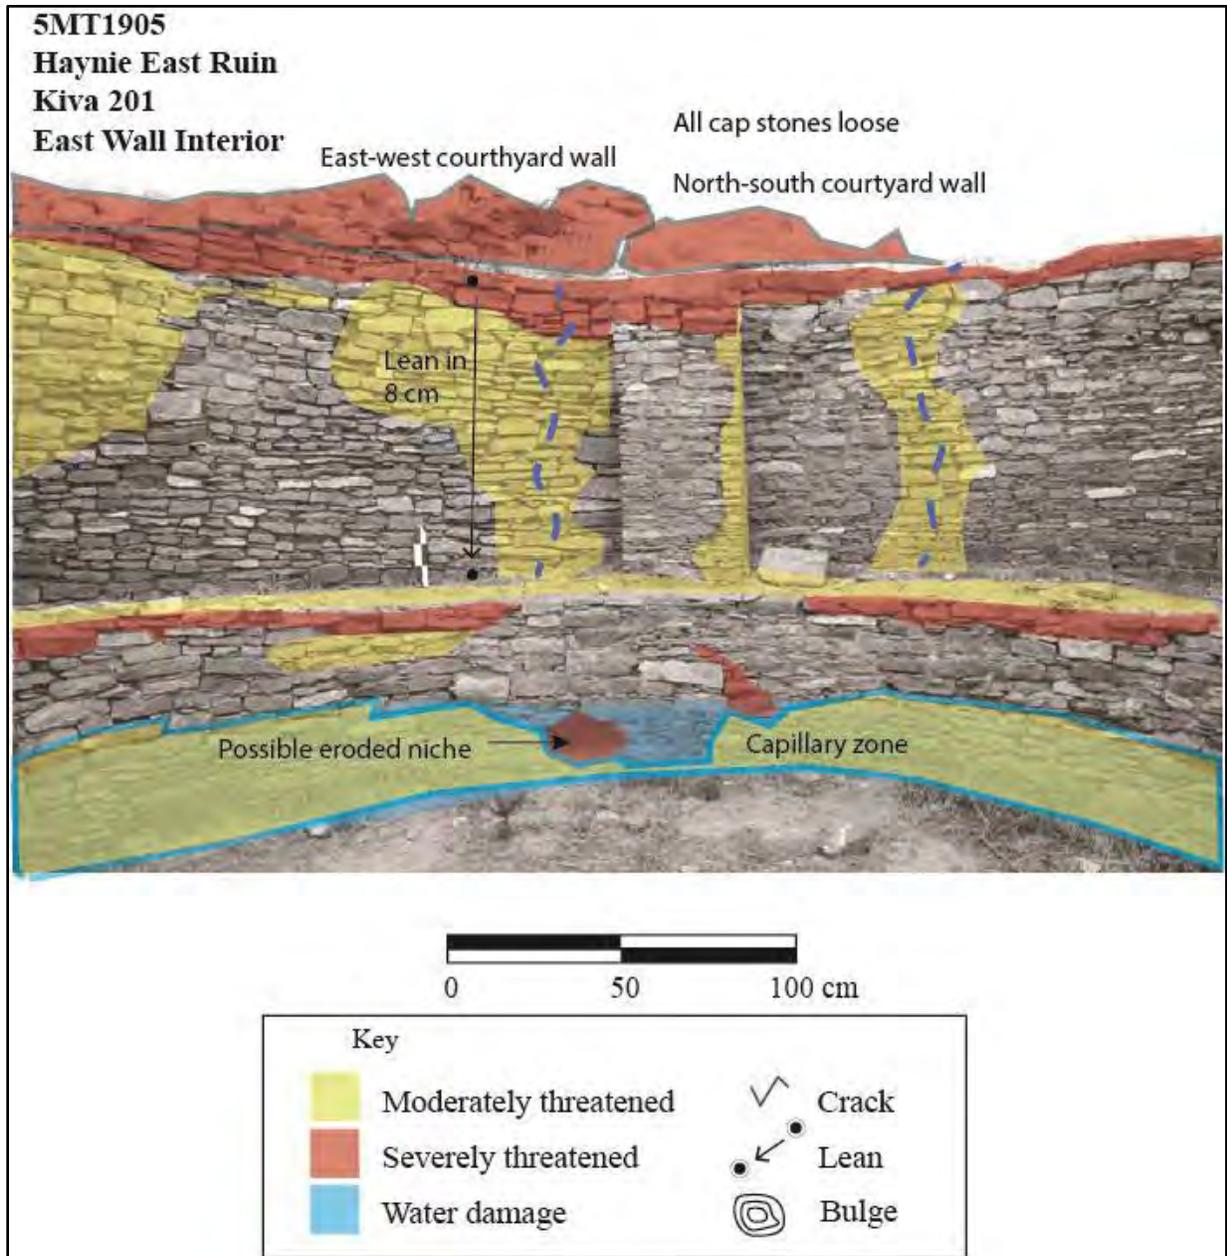
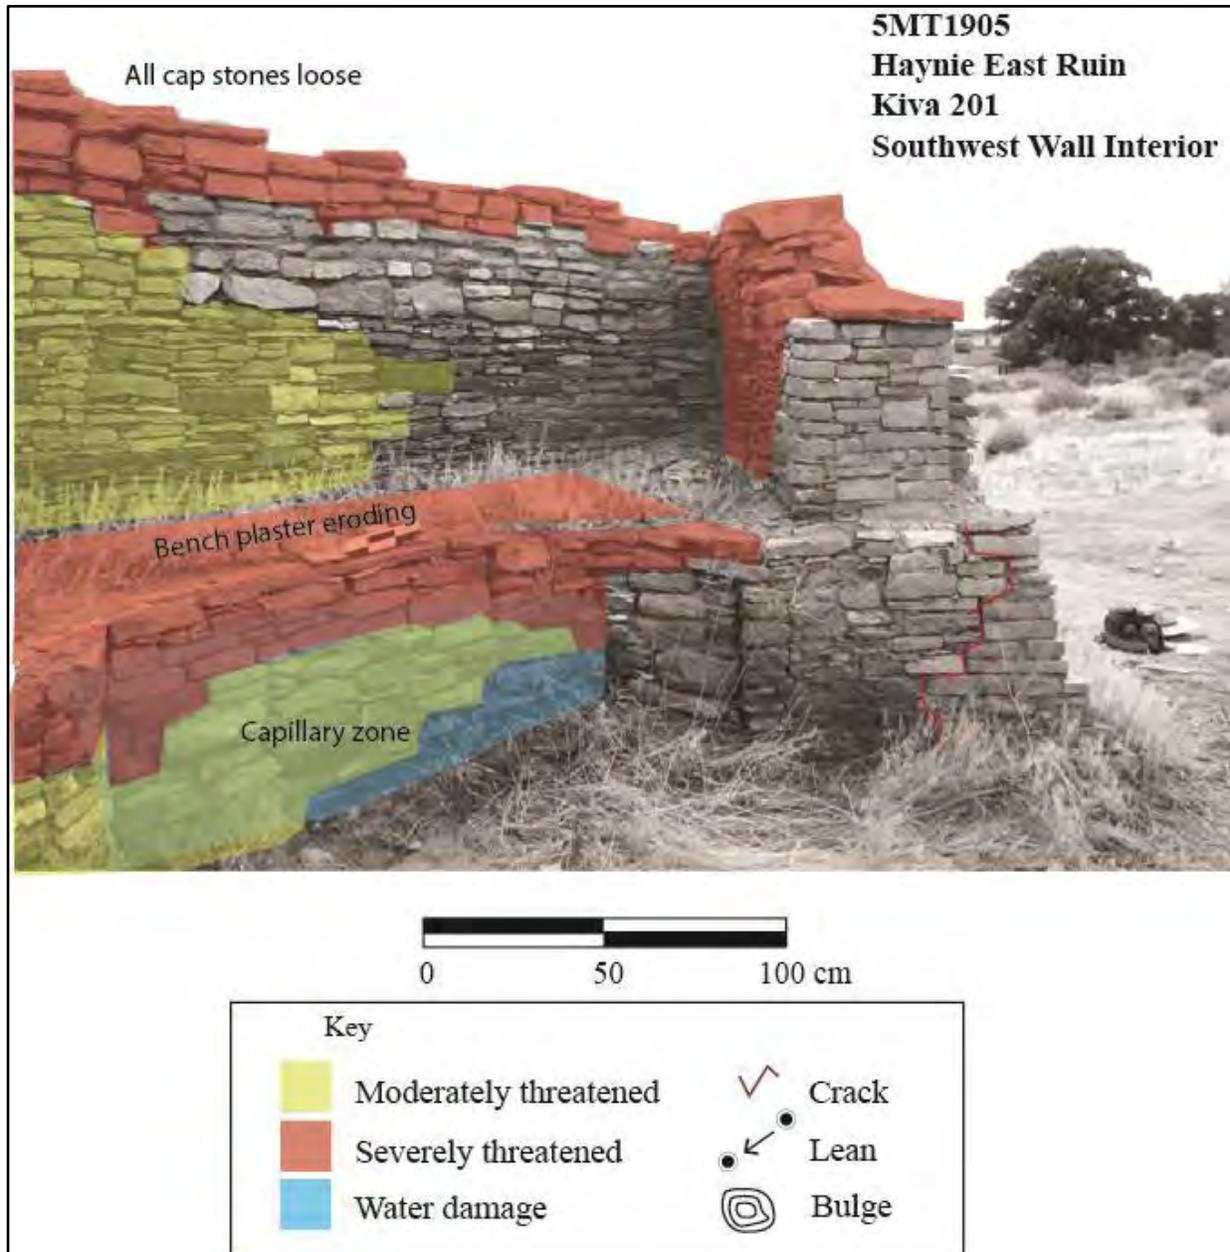
Structure 201, an above-ground, masonry kiva, is located in the southwestern portion of the great house. Prior to the 2024 stabilization, wall caps were in a deteriorated state with pockets of imminent veneer collapse. A 2-m-long and 0.5-m-wide portion of the east interior lining wall collapsed during the winter of 2023-2024 (Diederichs 2024). This resulted in a large hole in the

upper veneer and numerous visibly unstable stones. At the top of the southern recess severe mortar loss was evident. Treatment included the restacking and relaying of loose stones in the east interior lining wall. To complete wall capping, a relaying of one to three courses of stone was required for the southern recess and southeast pilaster.

Figure 15. Kiva 201 north interior lining wall condition issues annotated in 2017.

Figure 16. Kiva 201 east interior lining wall condition issues annotated in 2017.

Figure 17. Kiva 201 south interior lining wall condition issues annotated in 2017.

Diederichs recommends backfilling of Structure 201 to mitigate continued deterioration and erosion of bench tops, mortar loss, and deterioration of the previously-excavated subfloor vent.
