Excavation and Additional Studies at the Haynie Site (5MT1905) by the Crow Canyon Archaeological Center Annual Progress Report 2024

R. David Satterwhite, Susan C. Ryan, Steve Copeland, Reuven Sinensky
Jamie Merewether, and Kate Hughes

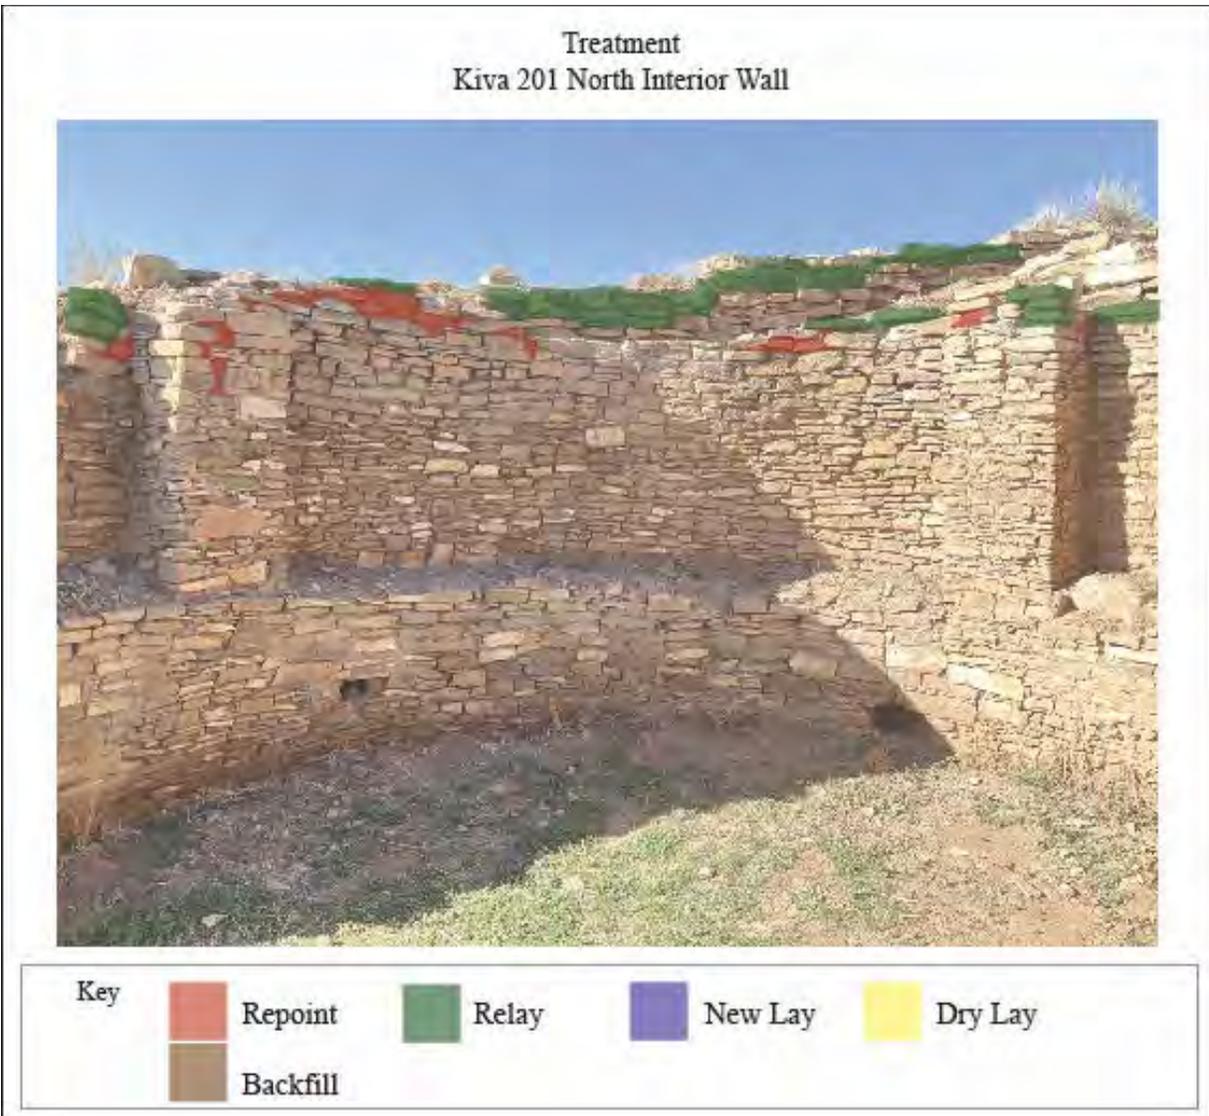
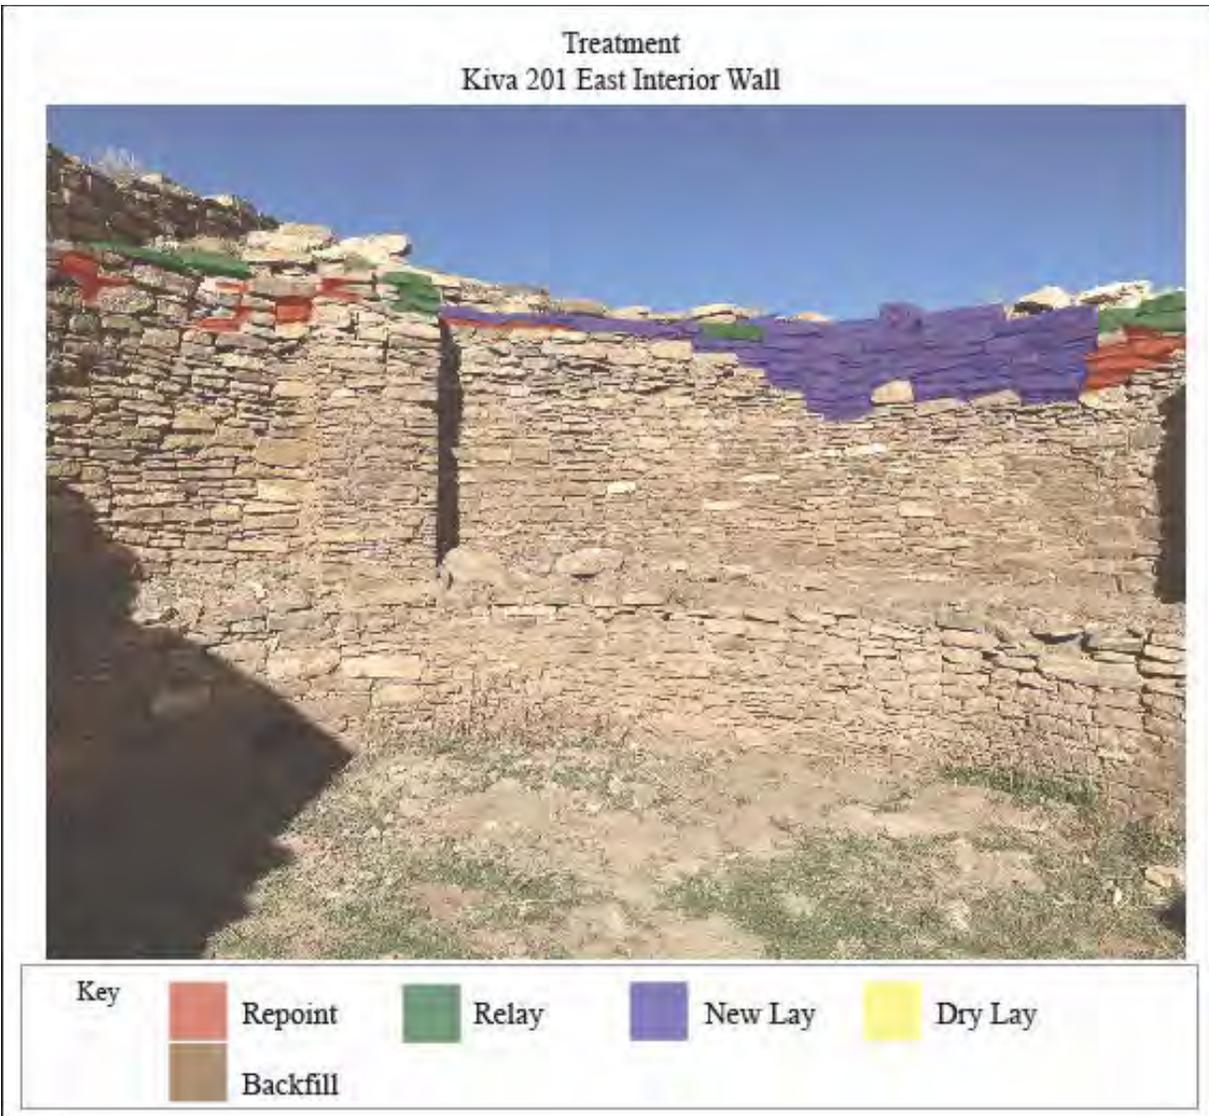
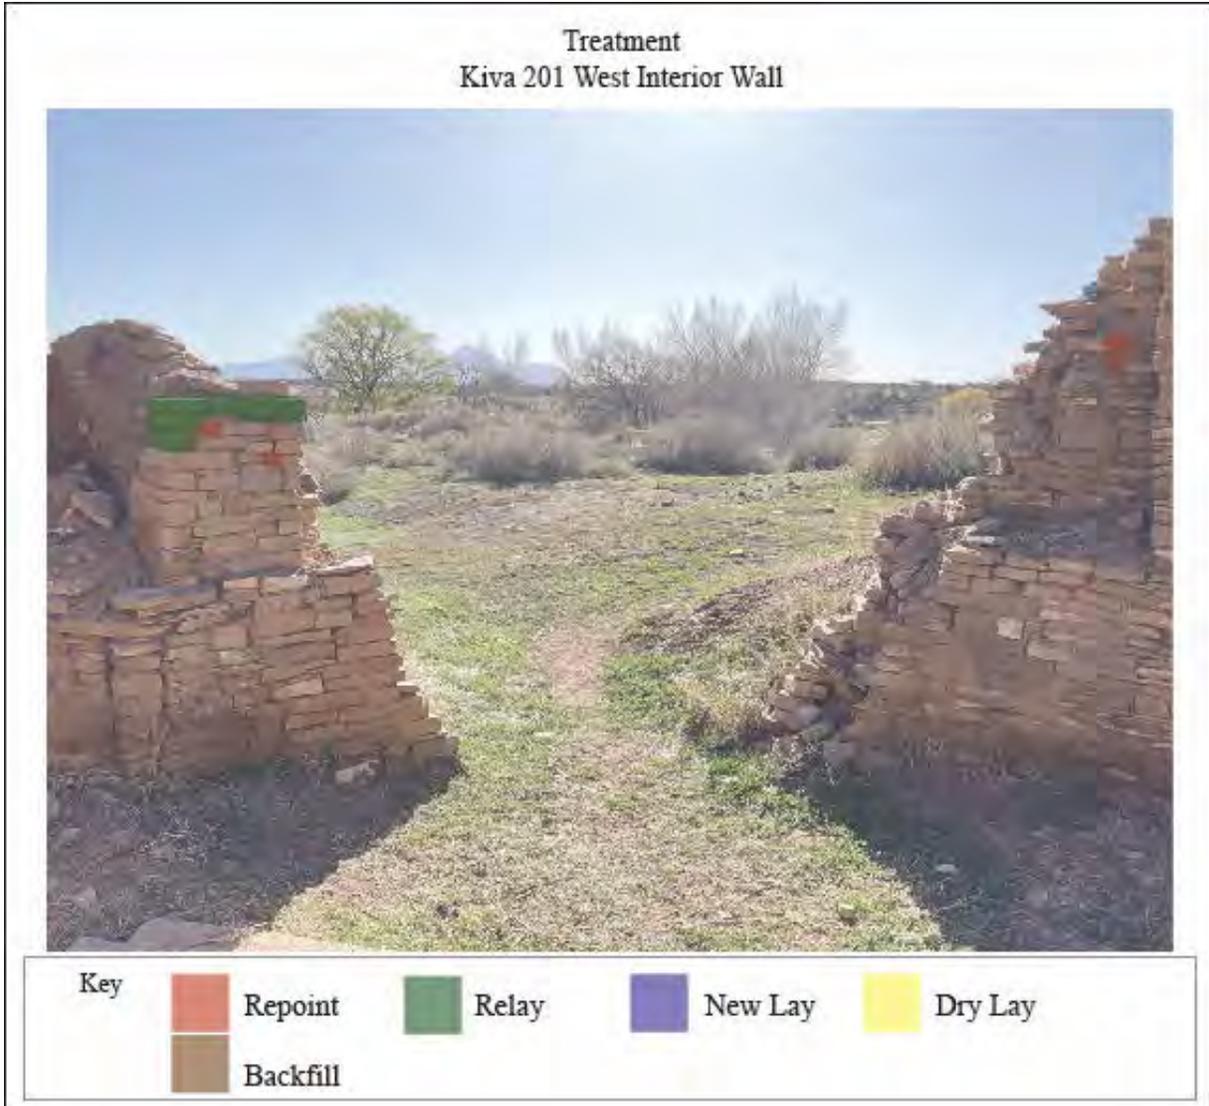
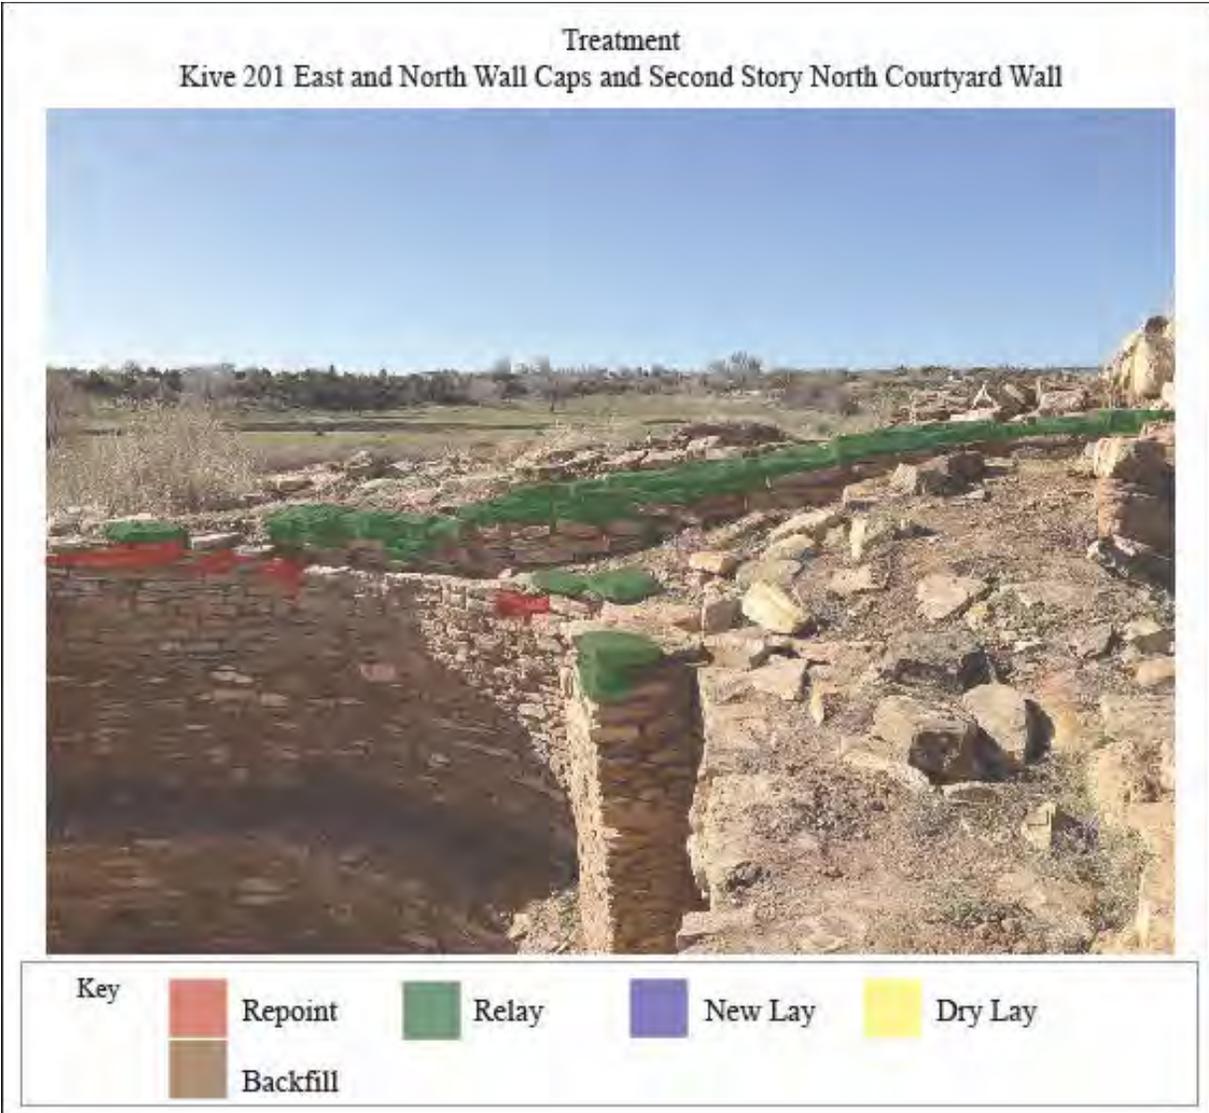
Figure 18. Overview of Kiva 201 from above after stabilization. View to the southwest.

Figure 19. Kiva 201 north interior lining wall after stabilization, annotated with conservation treatments.

Figure 20. Kiva 201 east interior lining wall after stabilization, annotated with conservation treatments.

Figure 21. Kiva 201 south interior lining wall after stabilization, annotated with conservation treatments.

Figure 22. Kiva 201 west interior lining wall after stabilization, annotated with conservation treatments.

Figure 23. Kiva 201 north interior wall of the second story courtyard after stabilization, annotated with conservation treatments.

upper veneer and numerous visibly unstable stones. At the top of the southern recess severe mortar loss was evident. Treatment included the restacking and relaying of loose stones in the east interior lining wall. To complete wall capping, a relaying of one to three courses of stone was required for the southern recess and southeast pilaster.

Diederichs recommends backfilling of Structure 201 to mitigate continued deterioration and erosion of bench tops, mortar loss, and deterioration of the previously-excavated subfloor vent.

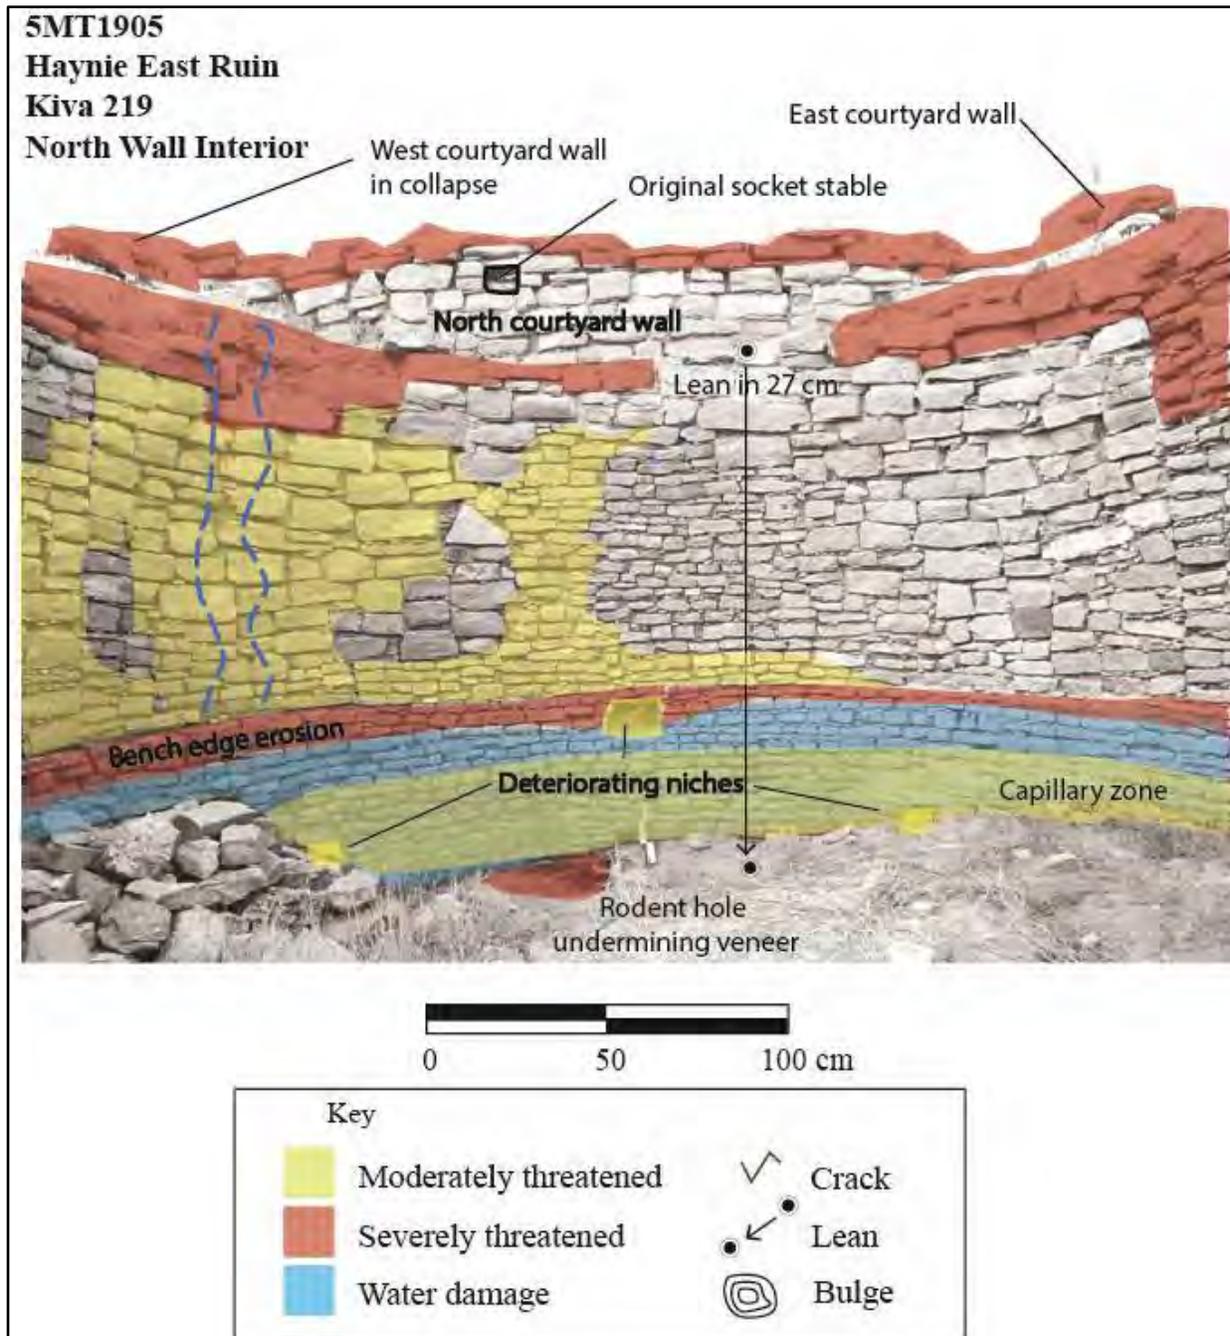
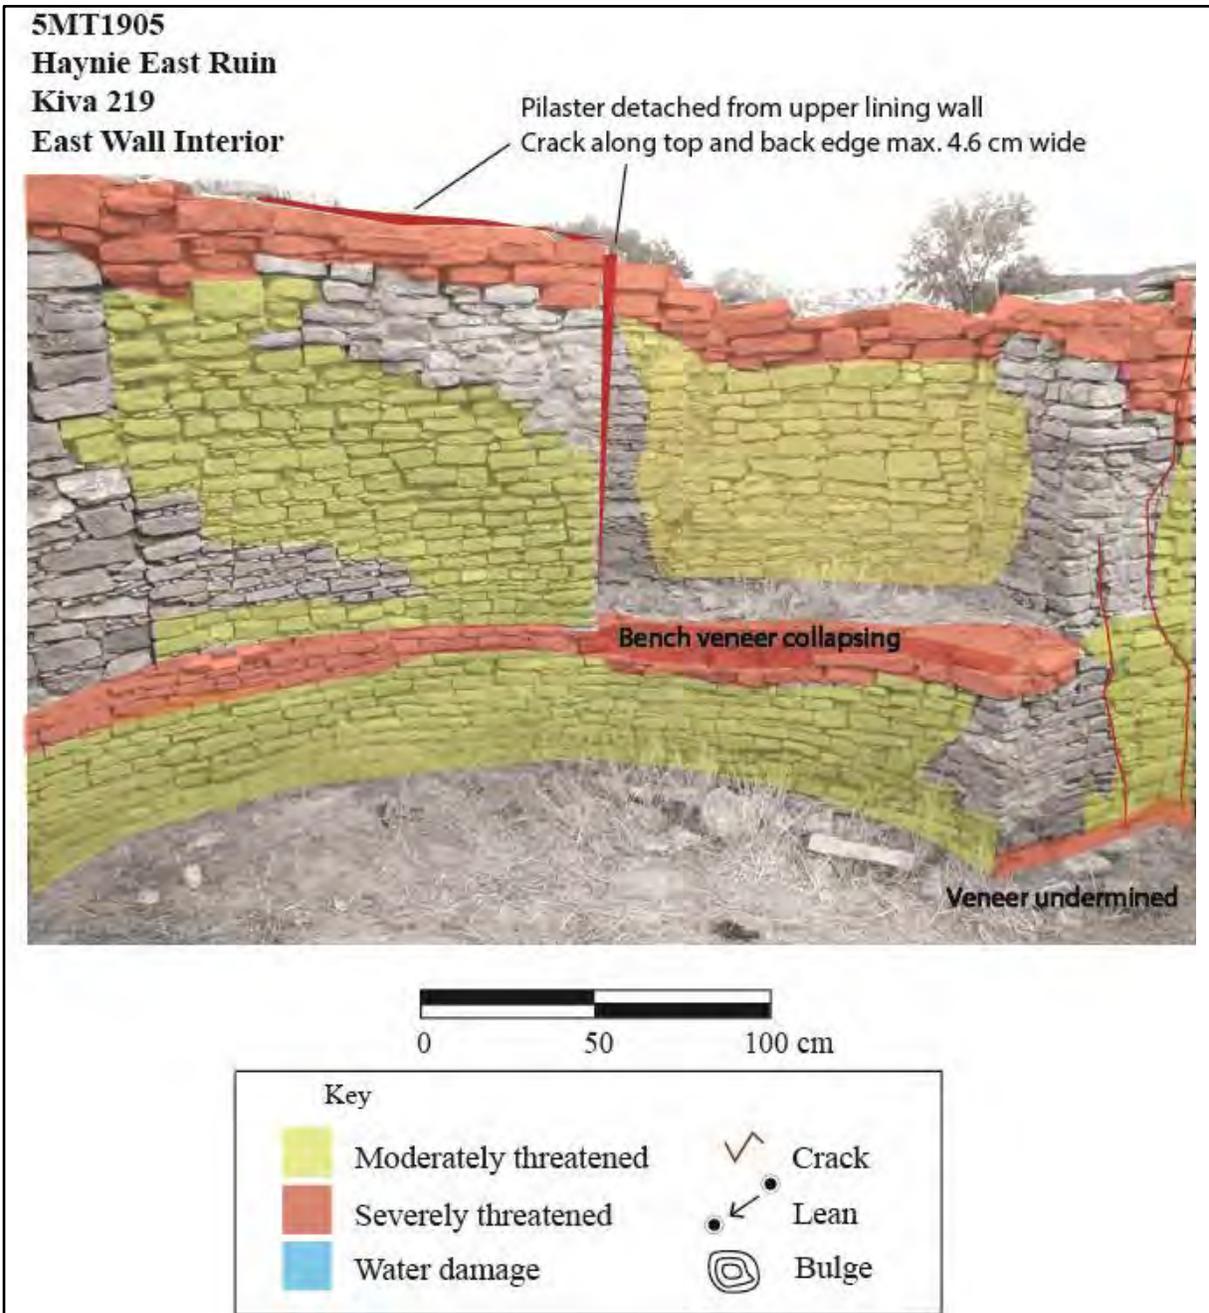
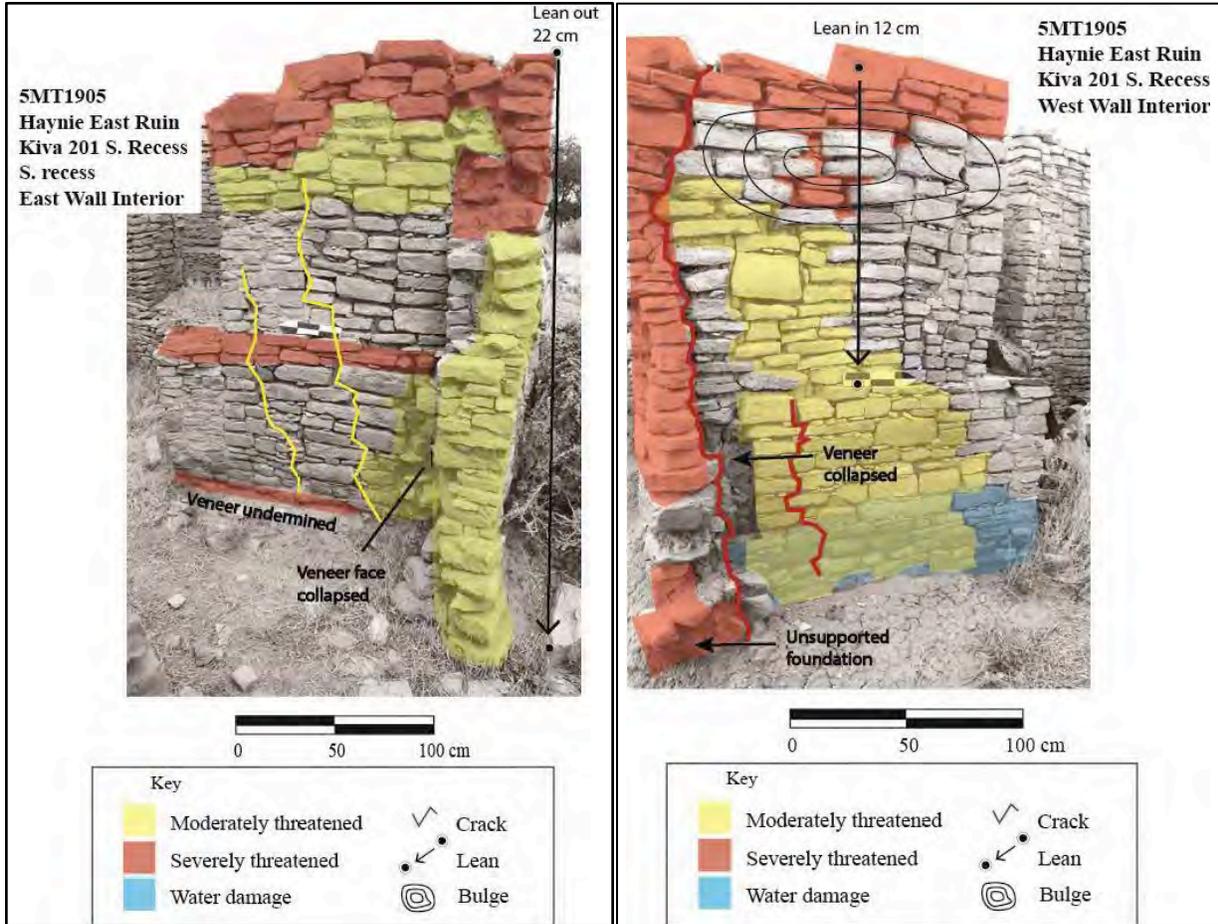
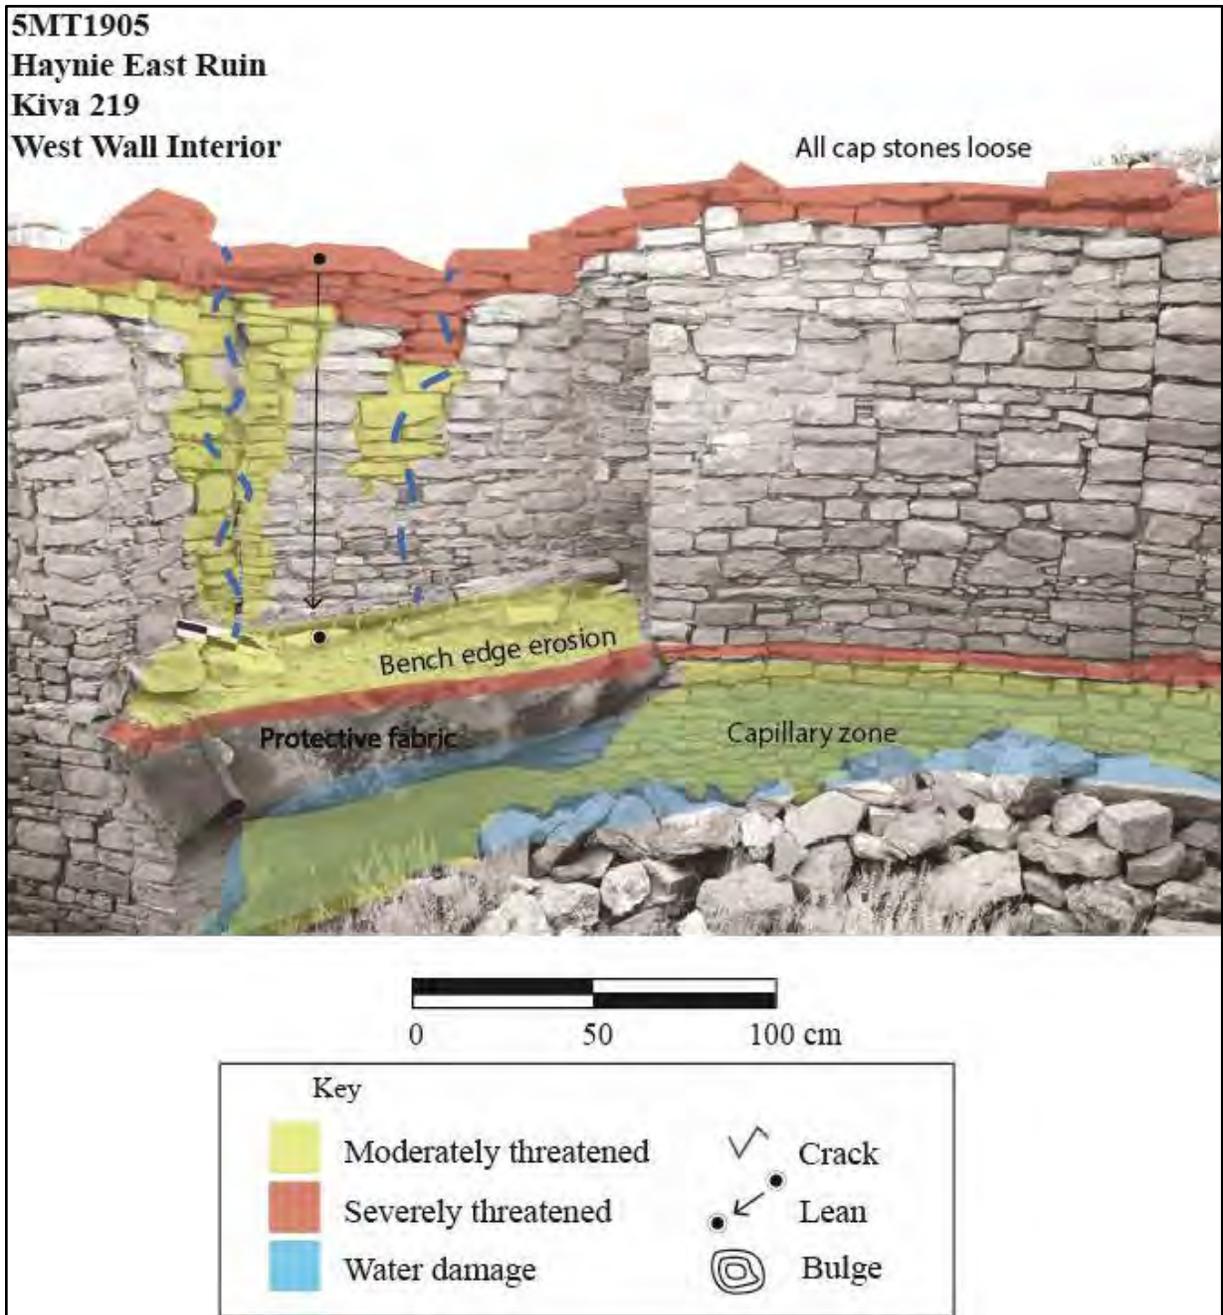
Structure 219, an above-ground, masonry kiva, is located in the southeast portion of the great house. It appears this structure is a later addition inserted into a 5-x-5-m square room. No stabilization work has occurred in this kiva since 2018 and the masonry prior to the 2024 treatments has severely deteriorated. Visible cracks appeared in the east and west veneers, the tops of both benches had lost mortar, and a section of the southeast bench veneer had collapsed to grade (Diederichs 2024).

Figure 24. Kiva 219 north interior lining wall condition issues annotated in 2017.

Figure 25. Kiva 219 east interior lining wall condition issues annotated in 2017.

Figure 26. Kiva 219 southern recess east and interior lining walls, condition issues annotated in 2017.

Figure 27. Kiva 219 west interior lining wall condition issues annotated in 2017.

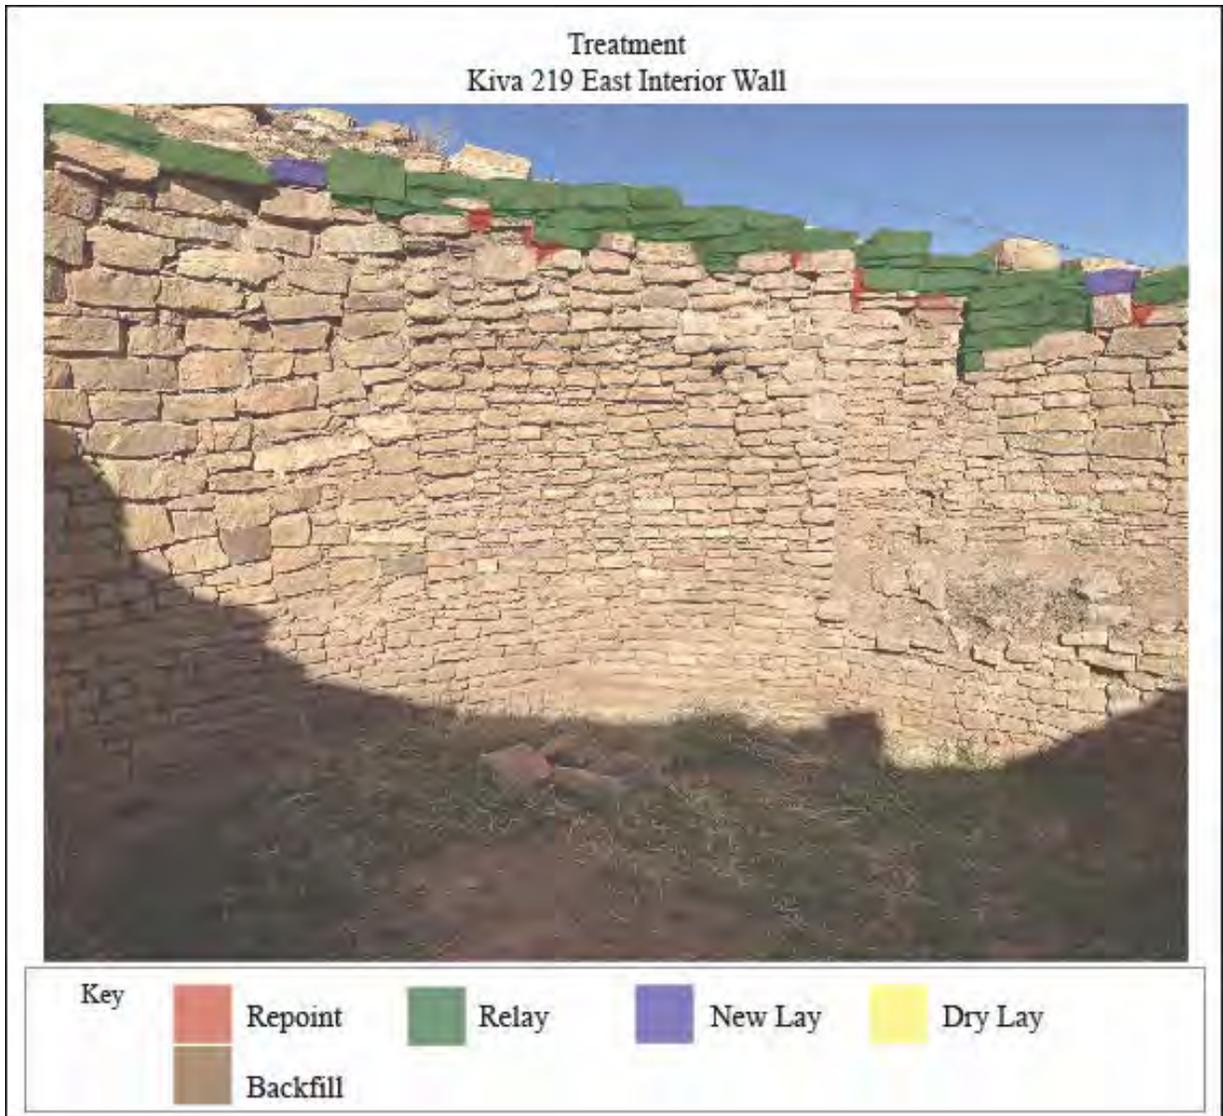
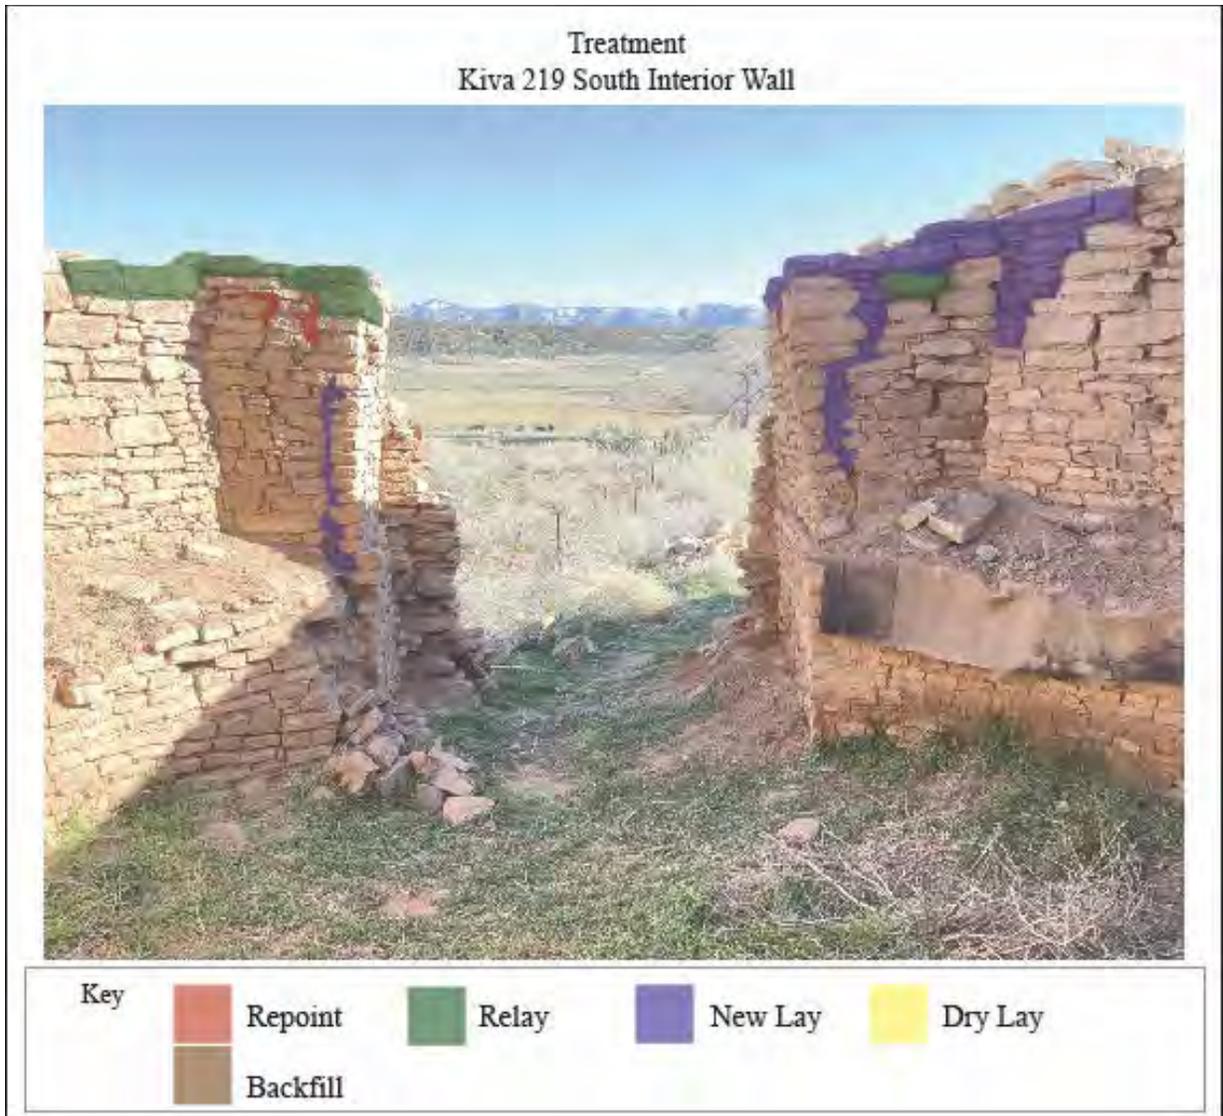
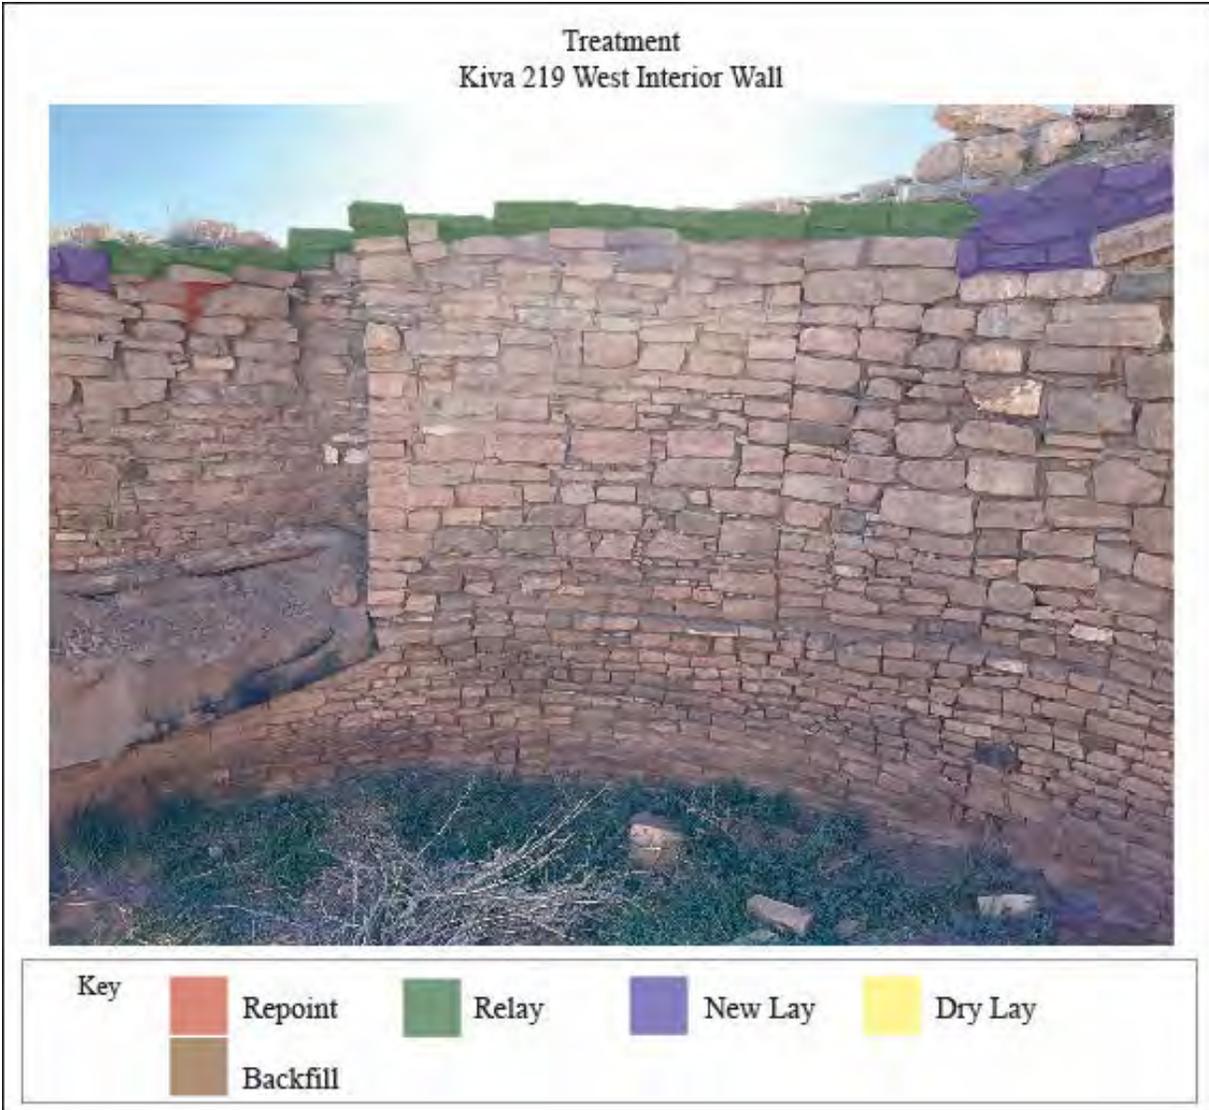
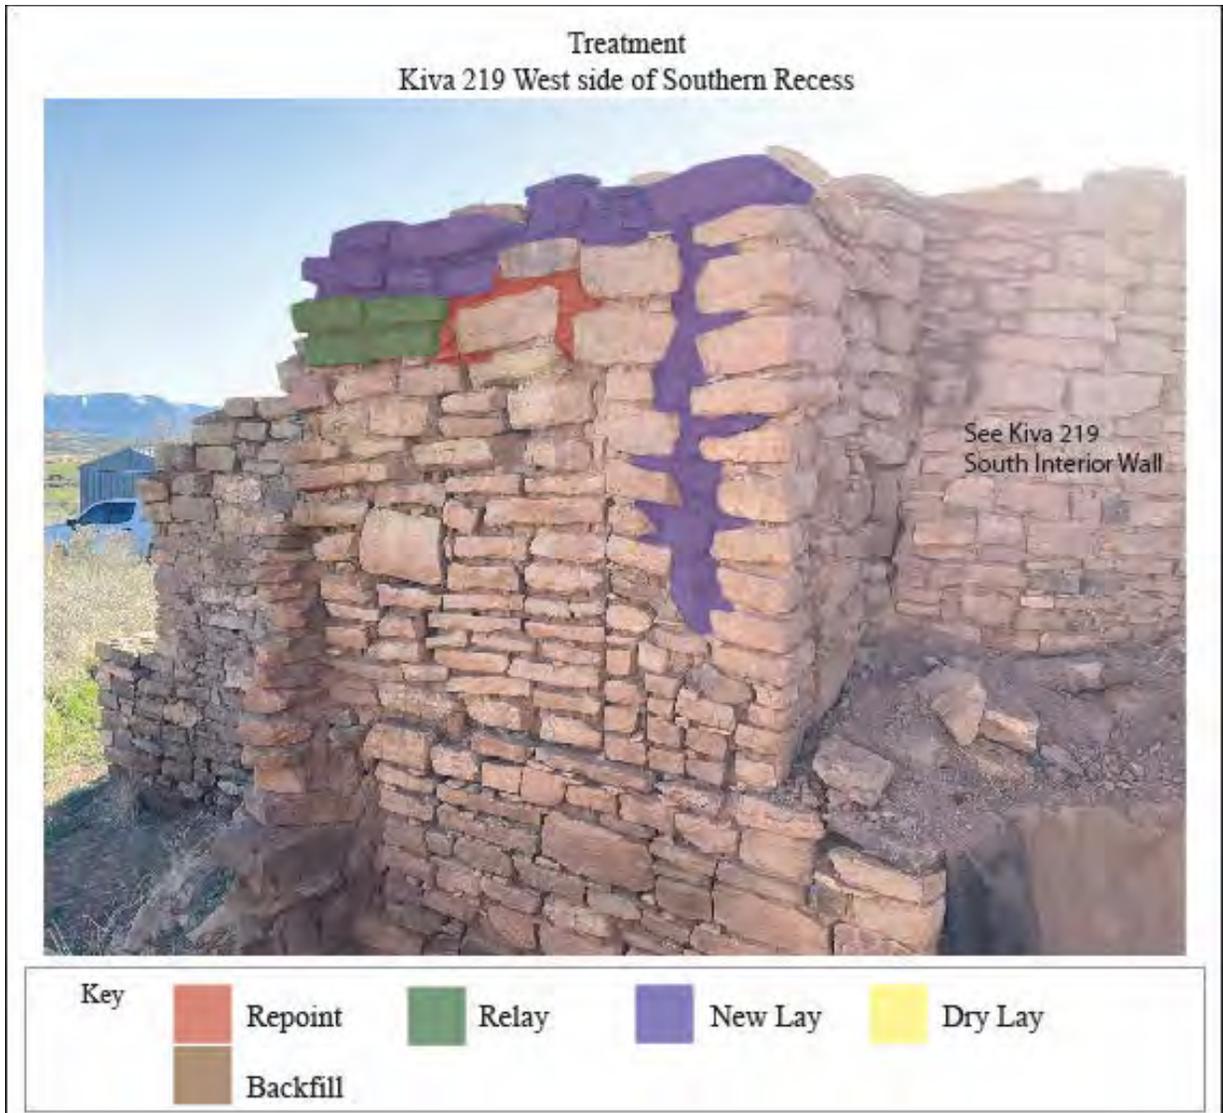
Figure 28. Overview of Kiva 219 from above after stabilization. View to the southwest.

Figure 29. Kiva 219 north interior lining wall after stabilization, annotated with conservation treatments.

Figure 30. Kiva 219 east interior lining wall after stabilization, annotated with conservation treatments.

Figure 31. Kiva 219 south interior lining wall after stabilization, annotated with conservation treatments.

Figure 32. Kiva 219 west interior lining wall after stabilization, annotated with conservation treatments.

Figure 33. Kiva 219 west side of southern recess after stabilization, annotated with conservation treatments.

Treatment included resetting all loose stones and the filling in of any holes with new-laid stone. Several top courses of veneer had to be reset and new stone laid to fill in holes. The severe cracks were cleaned out and repacked with stone and mortar to increase tensile strength of the structure's veneer.

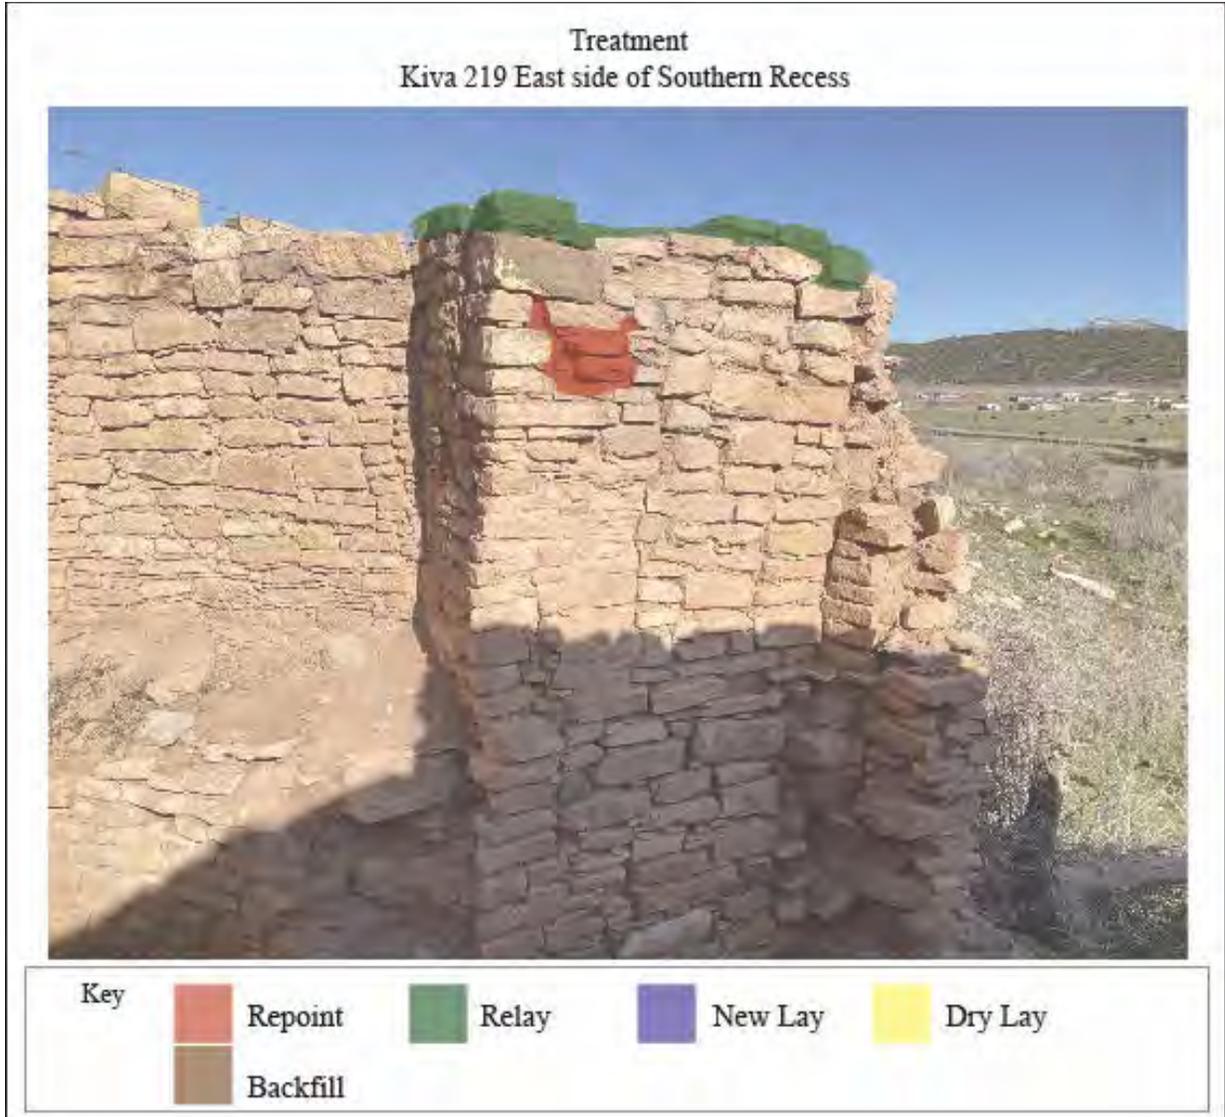
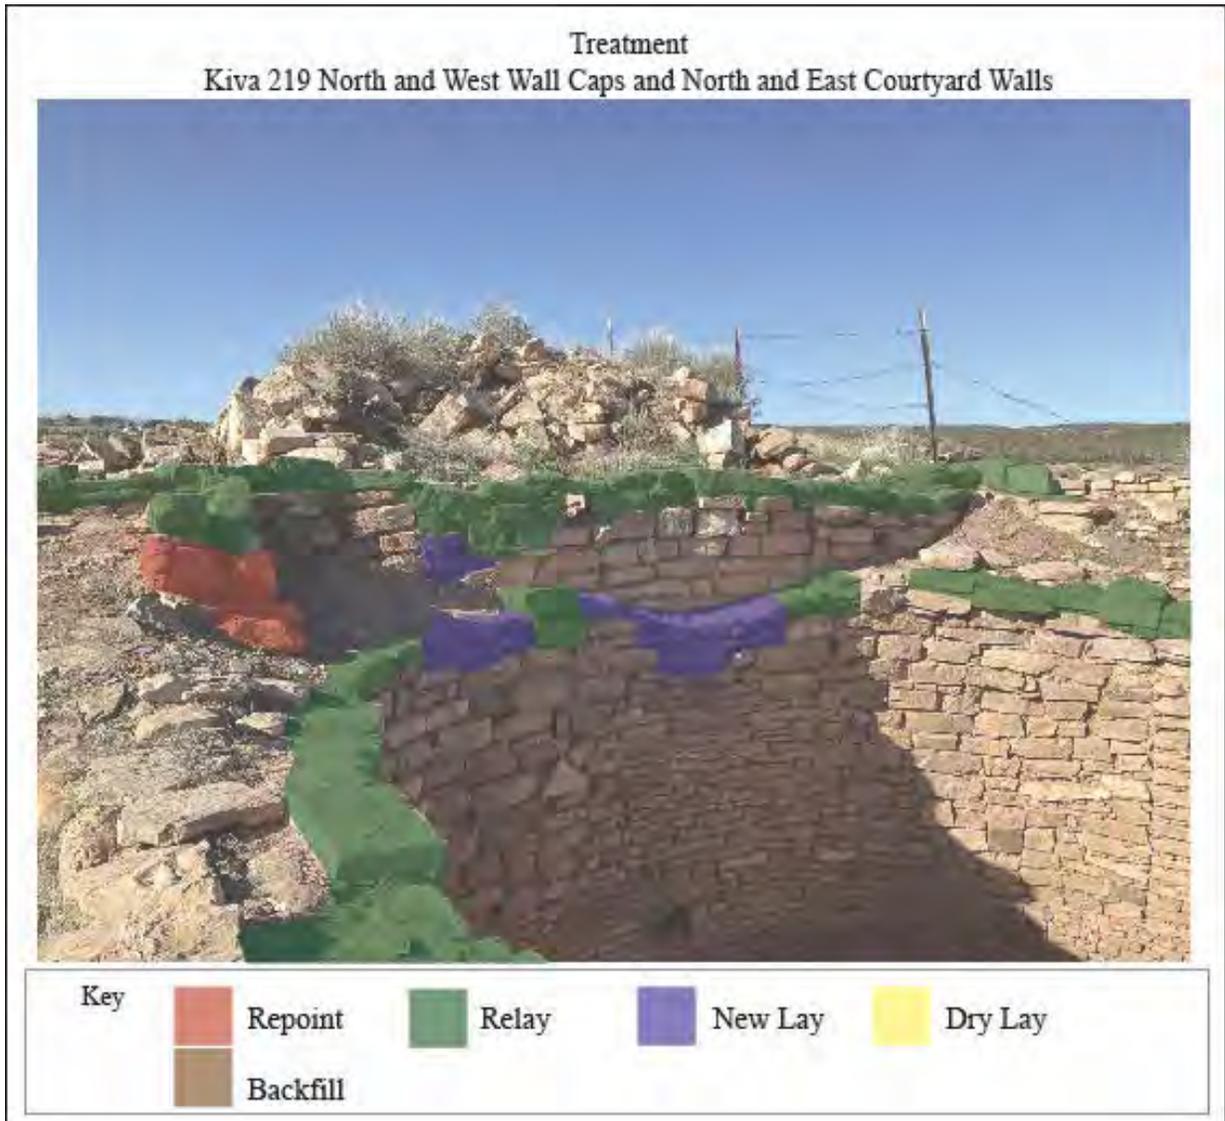
Figure 34. Kiva 219 east side of southern recess after stabilization, annotated with conservation treatments.

Figure 35. Kiva 219 north and east interior walls of the second story courtyard after stabilization, annotated with conservation treatments.

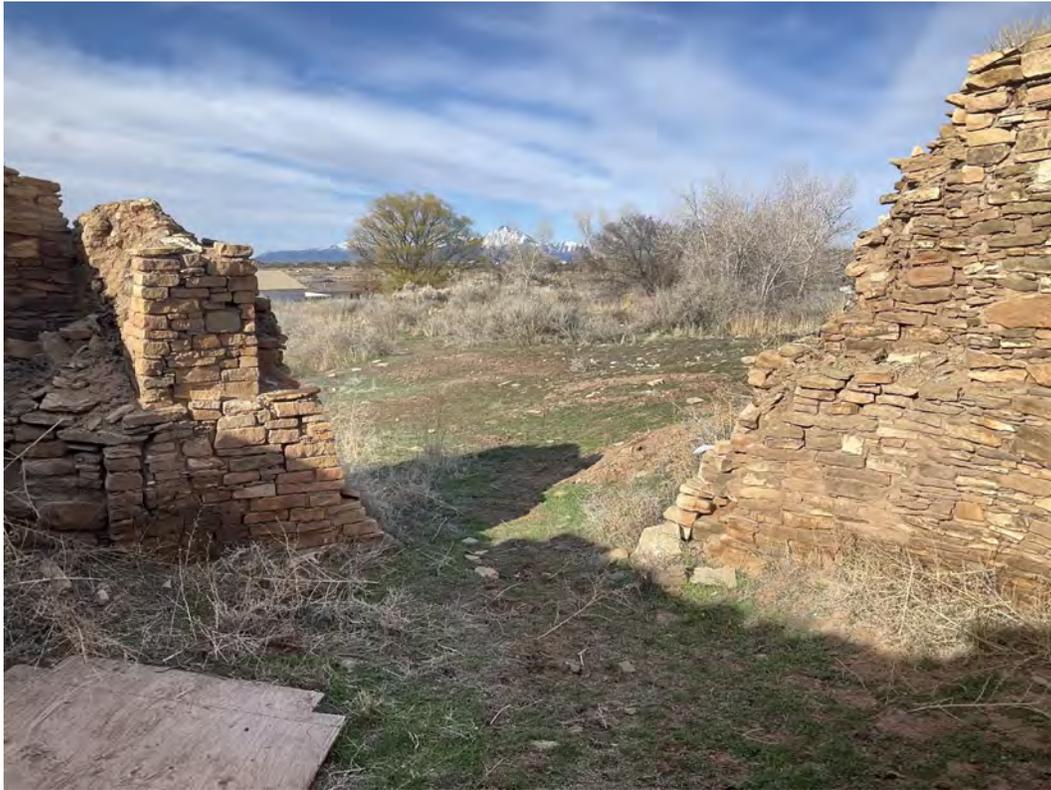
Muhasd001-10

Kiva 201 west interior wall facing west. Before treatment.

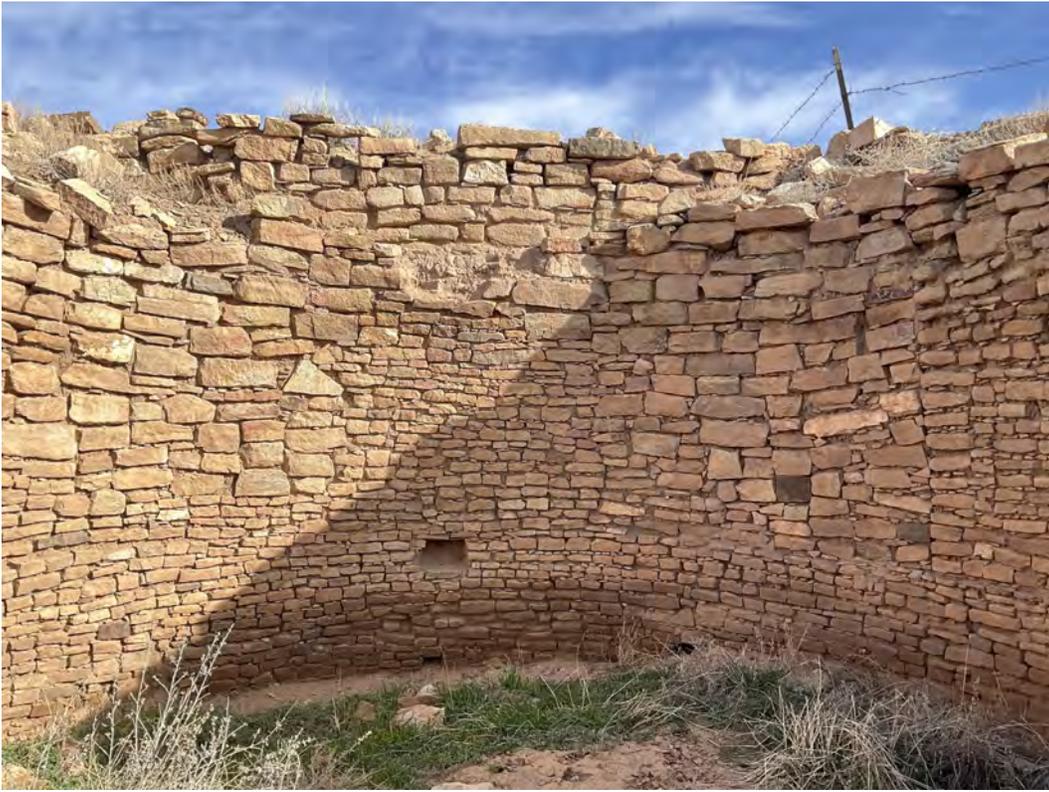
Muhasd001-12

Kiva 219 north interior wall facing north. Before treatment.

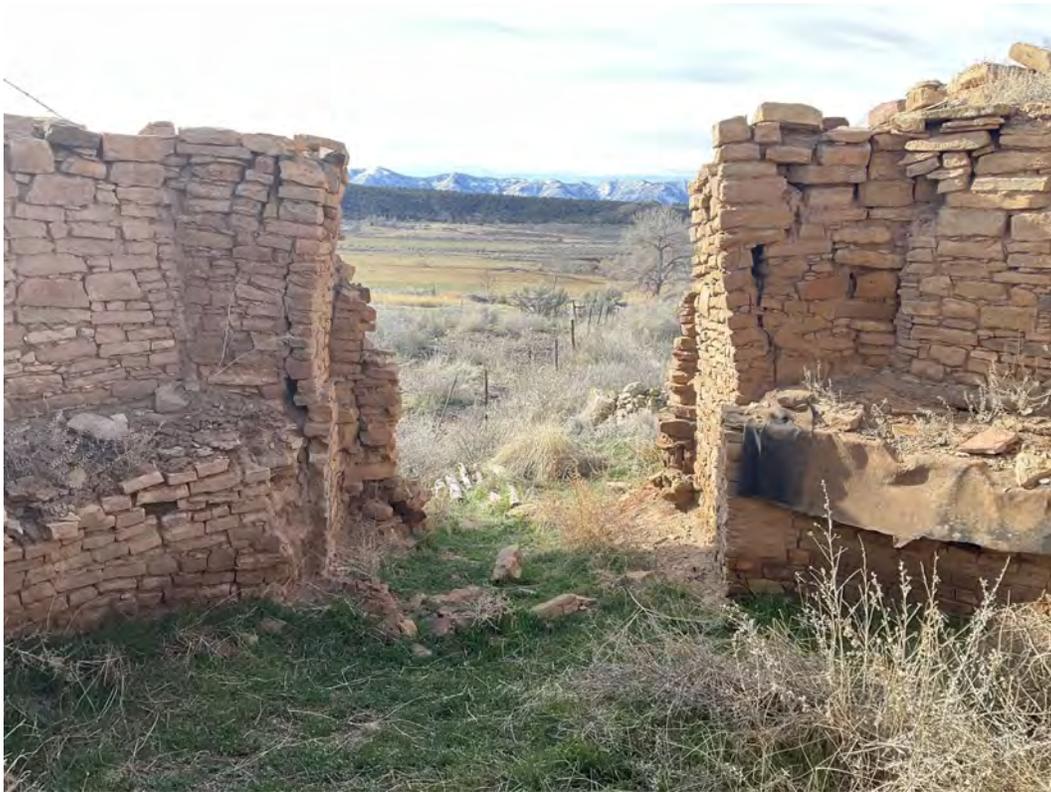
Muhasd001-14

Kiva 219 south interior wall facing south. Before treatment.
