Excavation and Additional Studies at the Haynie Site (5MT1905) by the Crow Canyon Archaeological Center Annual Progress Report 2024

R. David Satterwhite, Susan C. Ryan, Steve Copeland, Reuven Sinensky
Jamie Merewether, and Kate Hughes

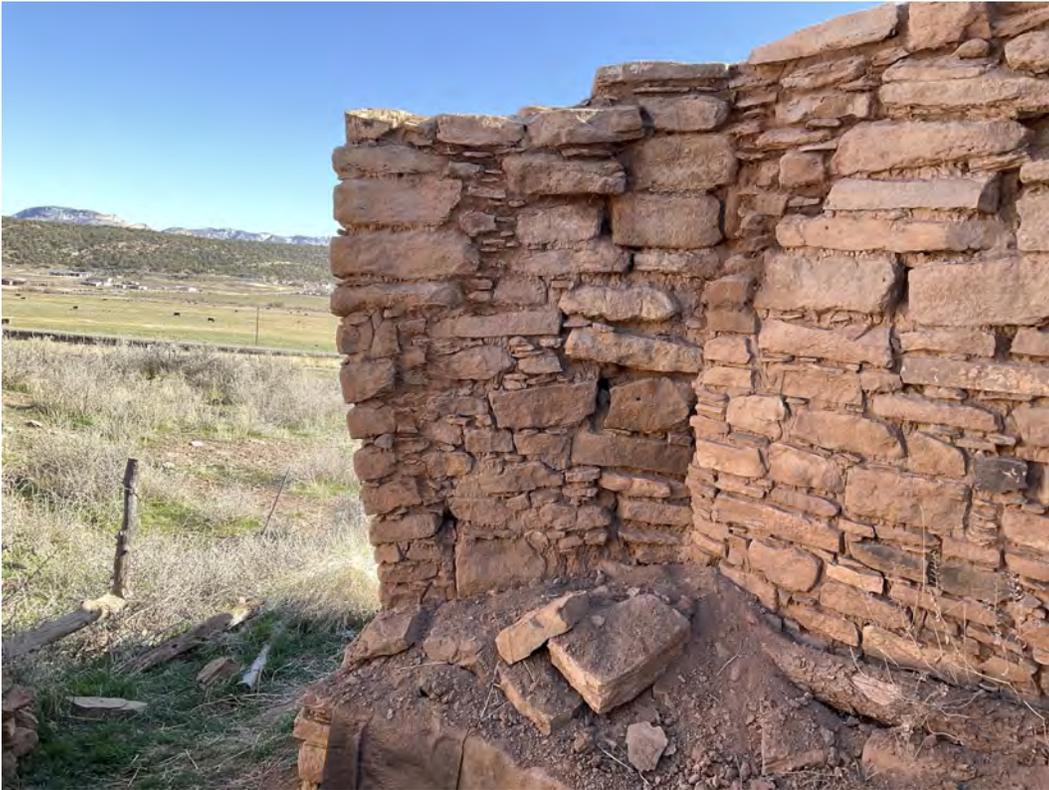
Kiva 219 southwest wall crack. After treatment.

Treatment included resetting all loose stones and the filling in of any holes with new-laid stone. Several top courses of veneer had to be reset and new stone laid to fill in holes. The severe cracks were cleaned out and repacked with stone and mortar to increase tensile strength of the structure's veneer.
